RE: Limited Mold Inspection & Sampling

Location: Toby Farms Elementary
201 Bridgewater Road, Brookhaven, PA 19015
Project #: 20220009

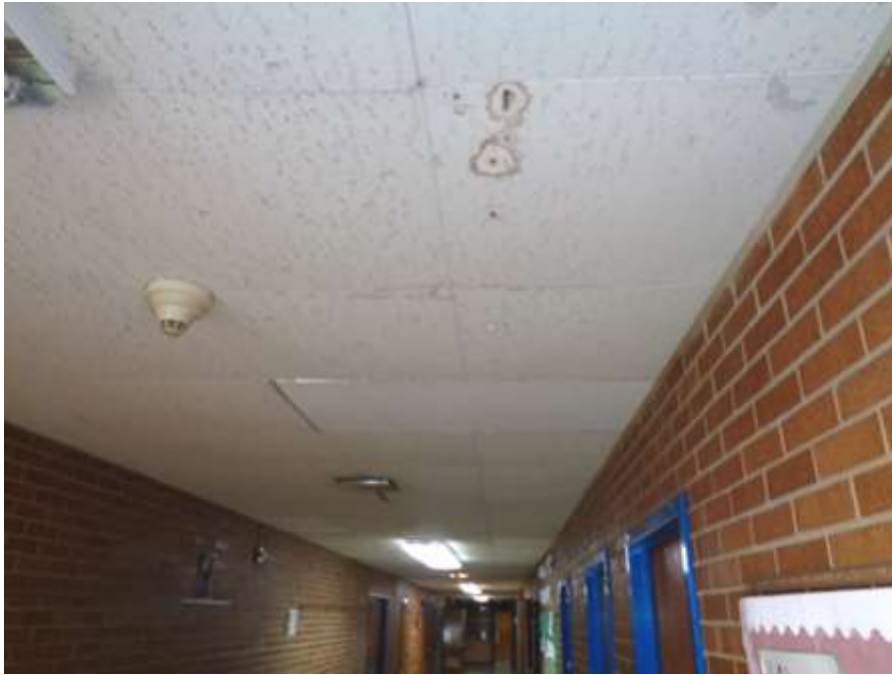
On February 2, 2022, ACER conducted a limited visual inspection of the basement, 1st, and 2nd floors. Suspected mold growth was observed in various locations on the following materials:

- One (1) ceiling tile in the 1st floor hallway behind Main Office.
- Wooden cabinets below classroom sinks in Rooms 26, 29, 28, 24, and D-31.

Photograph 1: Ceiling Tiles in 1st Floor Hallway.

ACER’s inspection and tape lift sampling confirmed mold growth to be present on the wood surfaces beneath the classroom sinks in Rooms 26, 29, 28, 24, and D-31. In addition, visible mold growth was observed on ceiling tiles located in the first-floor hallway behind the Main Office. ACER recommends the sink cabinets be replaced and if the plumbing associated with the sinks is to remain in place, that the valves and drain lines be repaired and checked for leaks prior to completion of installation. The areas under the sink cabinets should be cleaned and disinfected properly to prevent further mold growth.

The 2 foot by 2 foot ceiling tiles located in the 1st floor hallway were suspended with a spline system that could not be assessed without damaging the ceiling tiles. Therefore, ACER was unable to check above the ceiling tiles located in the 1st Floor Hallways to assess for the source of moisture. ACER recommends the affected ceiling tiles in the area be removed and the source of the moisture be determined and repaired prior to replacing ceiling tiles. Due to the potential for the ceiling tiles to contain asbestos, ACER recommends the ceiling tiles be sampled prior to any work.

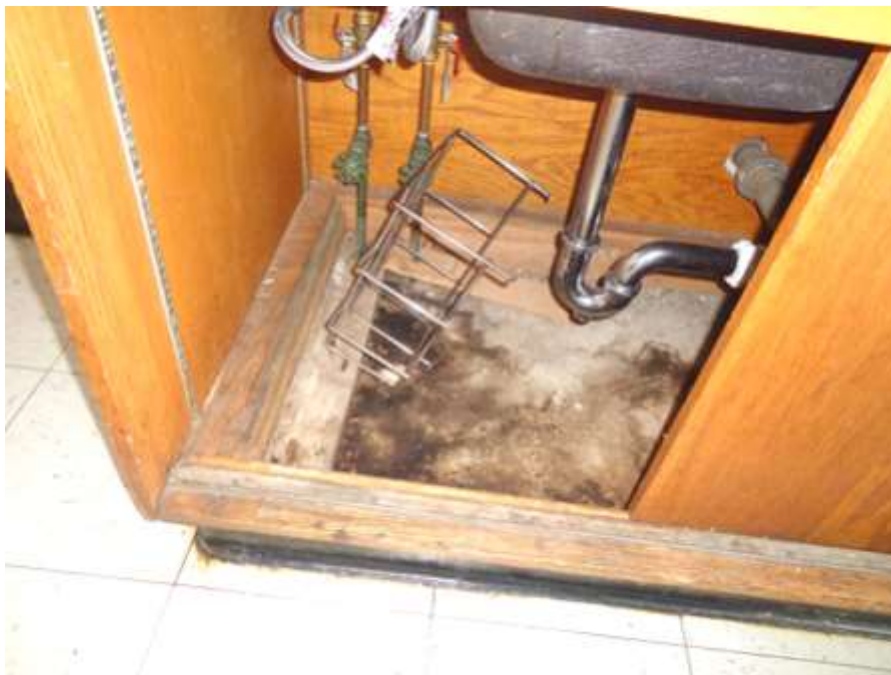
Sample ID/ Location/ Substrate	Sample Dimension	Fungal ID	Fungal Structures Observed	Fungal Density	Notes
220203-02-005 T-01 Rm 28 Under Sink	3/4" x 2 1/2"	Asp/Pen-like Chaetomium Stachybotrys	spores in clusters ascospores, ascomata, hyphae loose spores	NA <1 NA	Light fungal growth, most fungal structures in fragments.
220203-02-006 T-02 Rm 26 Under Sink	3/4" x 2"	<i>Chaetomium</i>	ascospores, ascomata, hyphae	5	Fungal growth, some fungal structures in fragments.

Photograph 2: Wood shelving below classroom sink in Room 28.

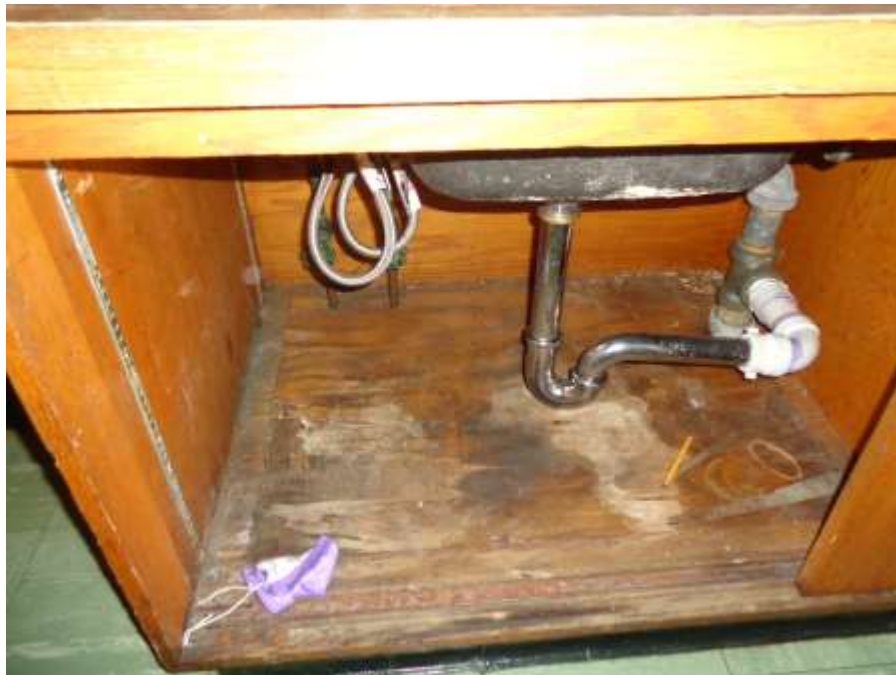
Photograph 3: Wood shelving below classroom sink in Room 26.

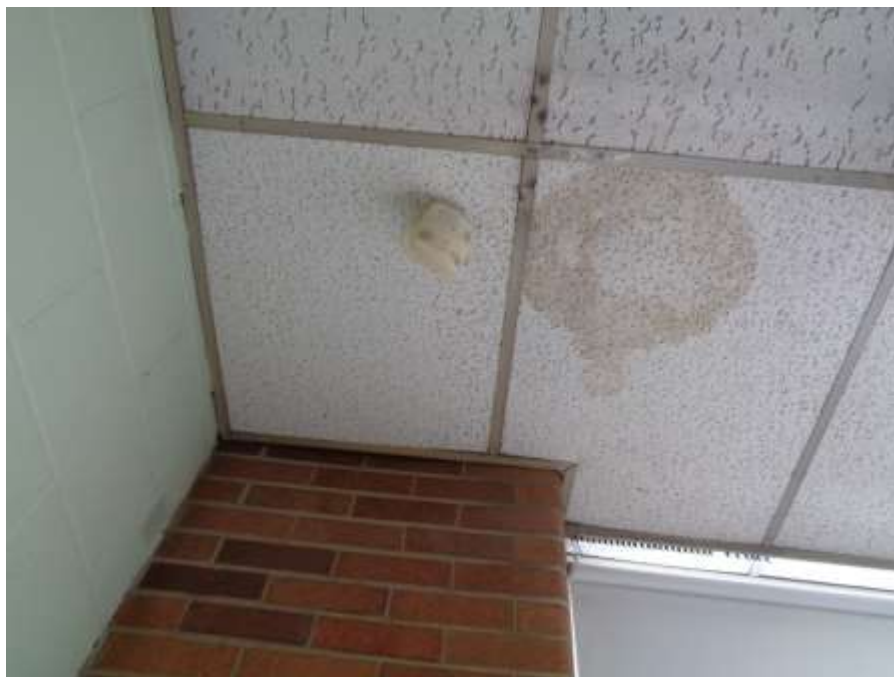
During the inspection, water damage was evident on ceiling tiles and tracks in classrooms and the hallways throughout. No mold growth was observed during the inspect, however, the potential exists for future mold growth if the water intrusion issue continues in these areas.

Photograph 4: Example of water damage on ceiling tiles in classrooms.

During the inspection, water damage was evident on ceiling tiles and tracks in classrooms and the hallways throughout. No mold growth was observed during the inspection, however, the potential exists for future mold growth if the water intrusion issue continues in these areas. These areas should be monitored to ensure the water intrusion is no longer active or persistent.

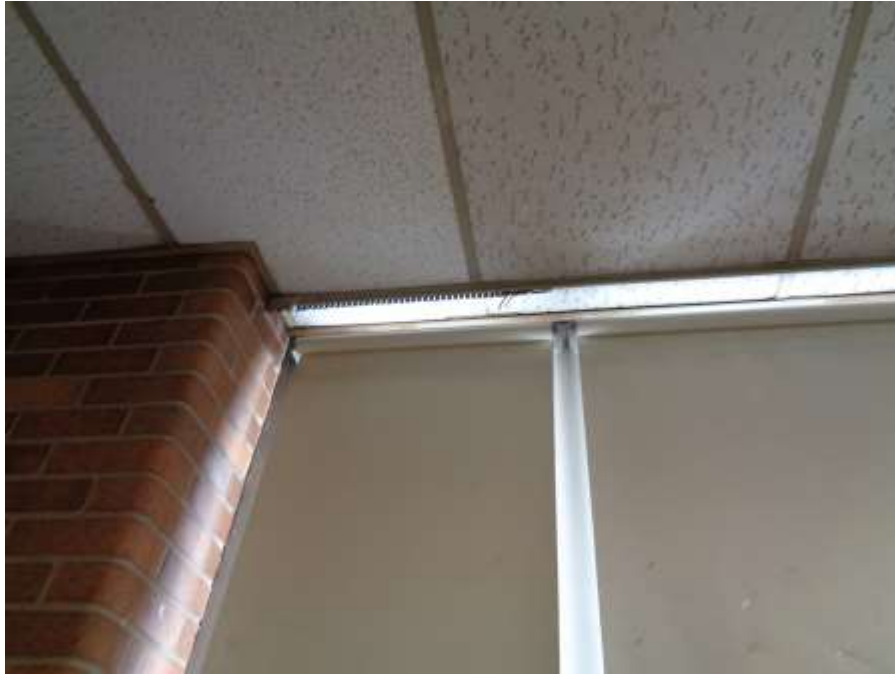
Photograph 5: Rusted ceiling tile tracks in Classroom A-5.

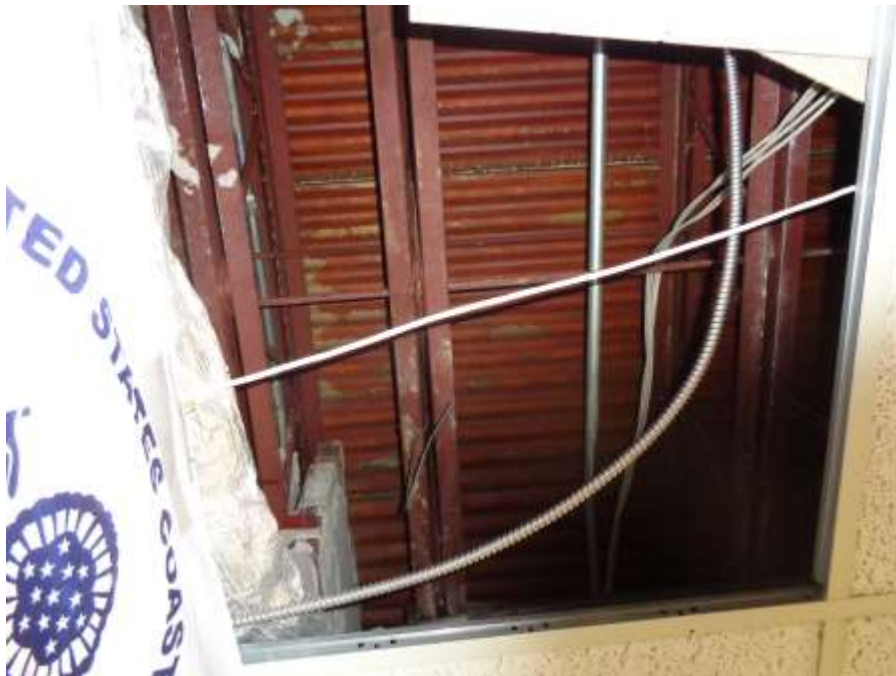
Photograph 6: Evidence of water intrusion above ceiling tiles.
