February 28, 2022

RE: Limited Mold Inspection & Sampling

Location: Chester High School
232 W. 9th Street, Chester, PA 19013
Project #: 20220011

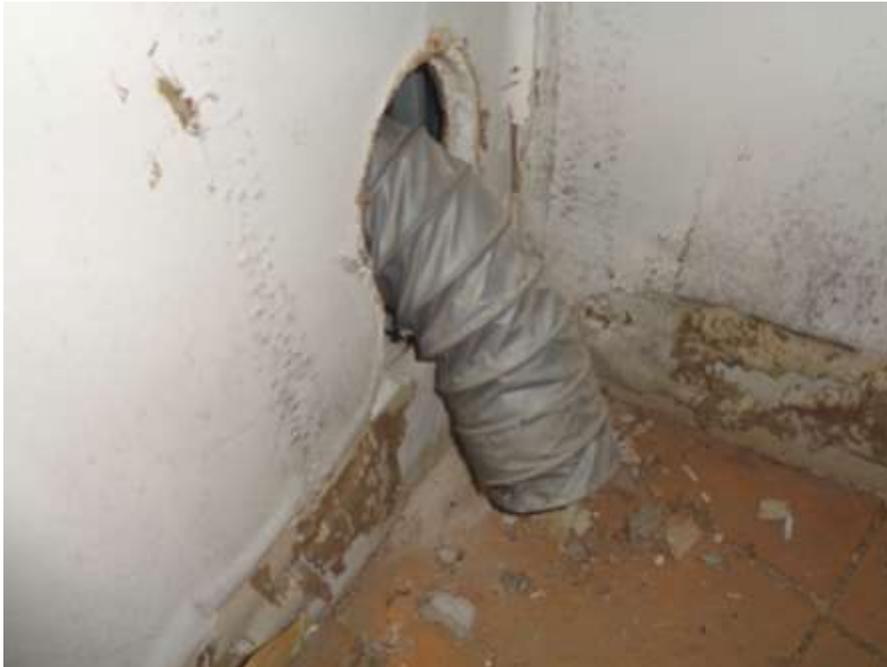
ACER’s inspection and tape lift sampling confirmed mold growth to be present on the drywall walls located in the boiler room, former dental room, cafeteria, Rooms C127, C233, and A510.

Photograph 1: Drywall in the former dental lab.

1. The drywall walls the above referenced rooms should be removed. All exposed surfaces should be cleaned and disinfected properly to prevent further mold growth.
2. The wall cavity should be inspected by ACER while opened to further investigate the cause of the of the water intrusion and to verify all mold has been remediated.

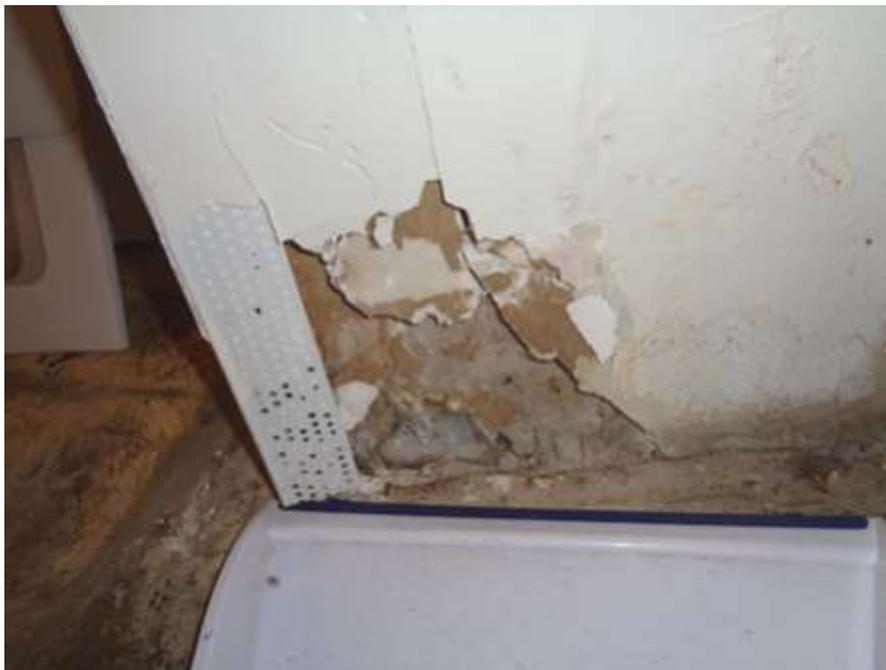
Photograph 2: Drywall in Room C127.

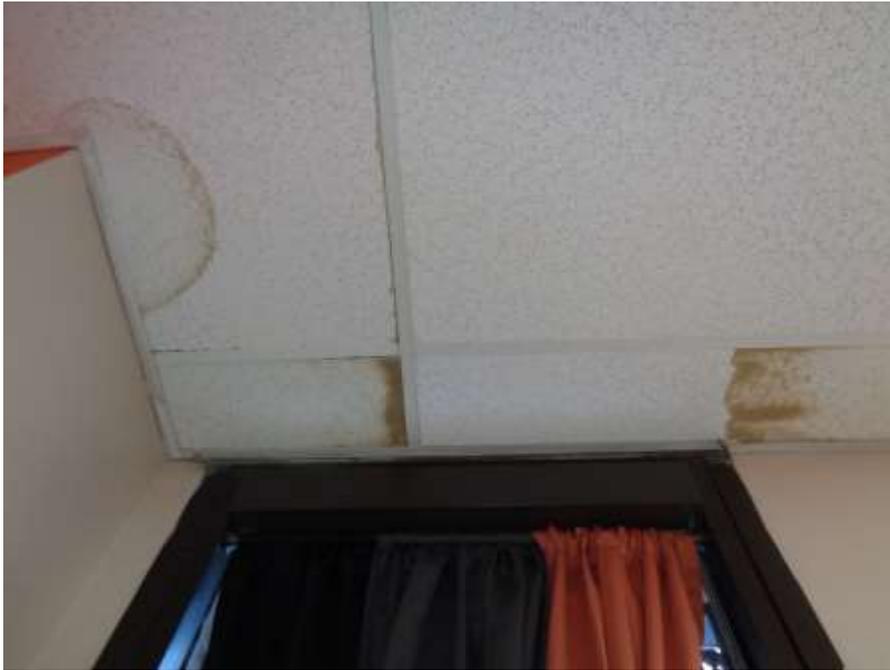
Ceiling tiles located in rooms referenced in the Visual Inspection showed visible mold growth and water damage. The majority of the ceiling tiles located on the 1st through 4th floor were located below classroom unit ventilators located on the floors above. Some stained ceiling tiles in 2nd floor classrooms were located below kitchen floor drains which leaked. The mold growth and water

Photograph 3: Ceiling tile in Room A121.

5. The affected ceiling tiles in the areas should be removed and the source of the moisture be determined and repaired prior to replacing ceiling tiles. Due to the potential for the ceiling tiles to contain asbestos, ACER recommends the ceiling tiles be sampled prior to any work.

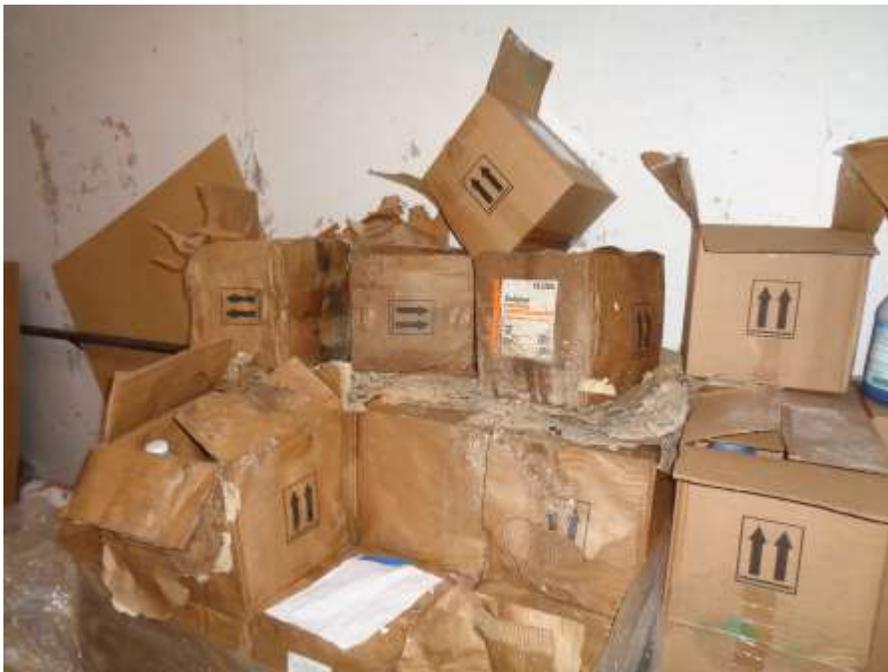
Photograph 4: Moldy boxes in long storage hallway.

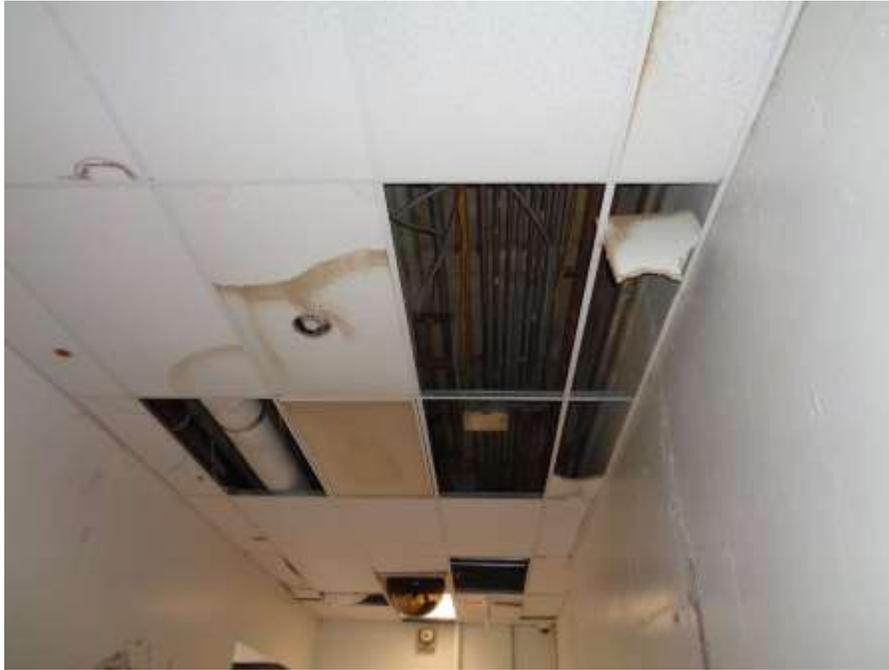
Photograph 5: Ceiling tiles in long storage hallway.

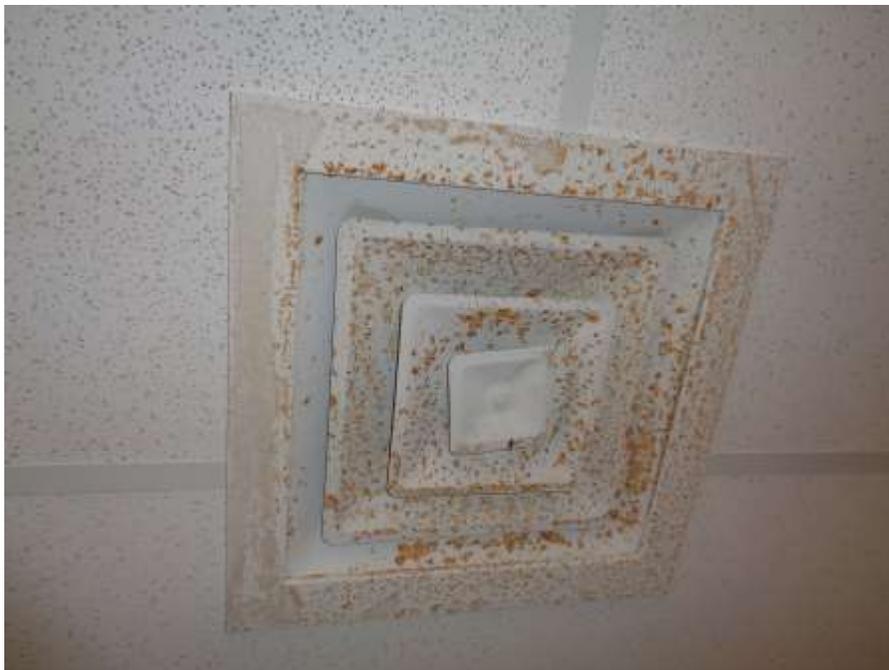
ACER's inspection and tape lift sampling confirmed mold growth to be present on the metal ducting in the Boys and Girls Locker Rooms, and Gym. Mold growth was also observed on metal diffusers located in the Main Office suites on the 2nd, 3rd and 4th floors. All metal materials should be cleaned and disinfected properly to prevent further mold growth. Additionally, cardboard boxes and fiberglass pipe insulation in the long storage hallway and Girl's Locker Room Coach's Office, showed visible mold growth. The cardboard boxes and fiberglass should be removed and disposed of. The floor around the boxes and the pipes should be cleaned and disinfected. The piping should be reinsulated once remediation has been confirmed to be satisfactorily completed.

Photograph 6: Diffuser in 2nd Floor Office suite.

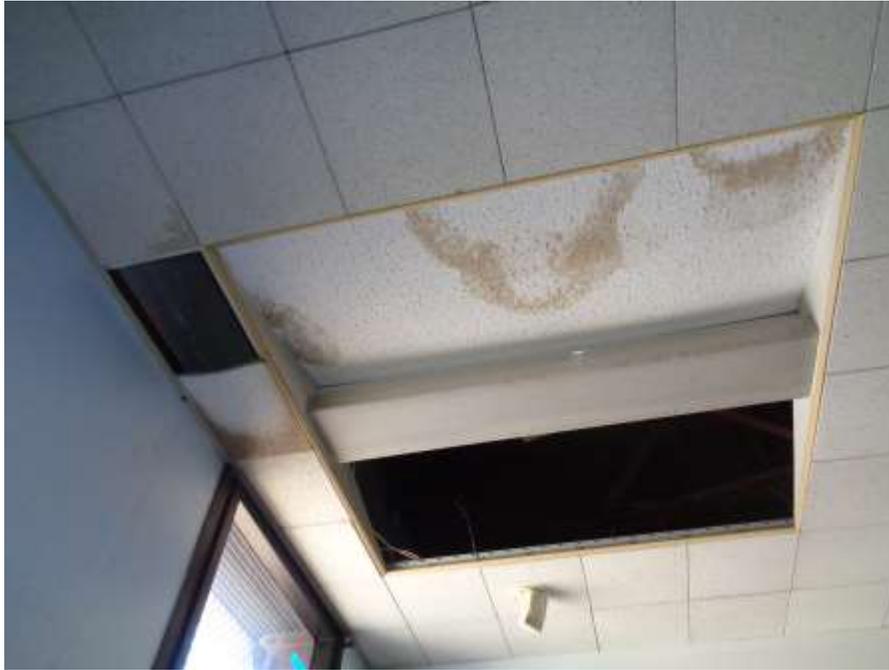
Photograph 7: Ceiling tiles in Room C233.

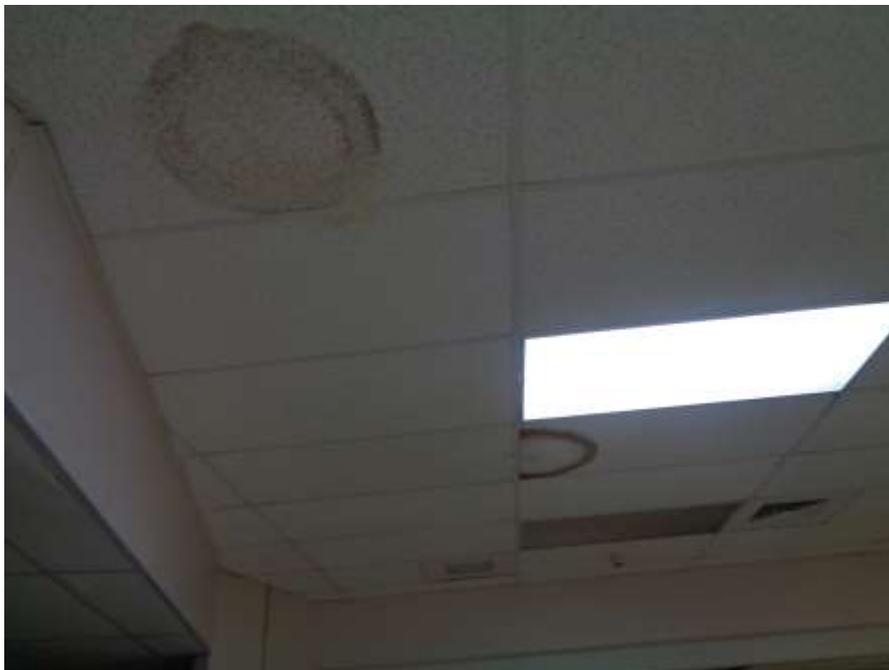
Photograph 8: Ceiling tiles below kitchen.

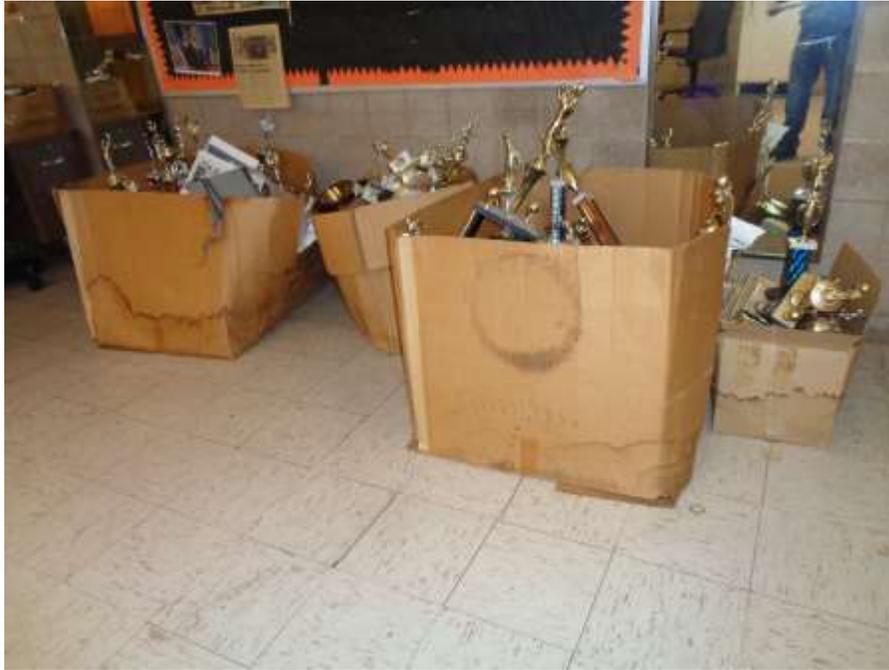
Photograph 9: Moldy boxes in Girl's Coach's Office.

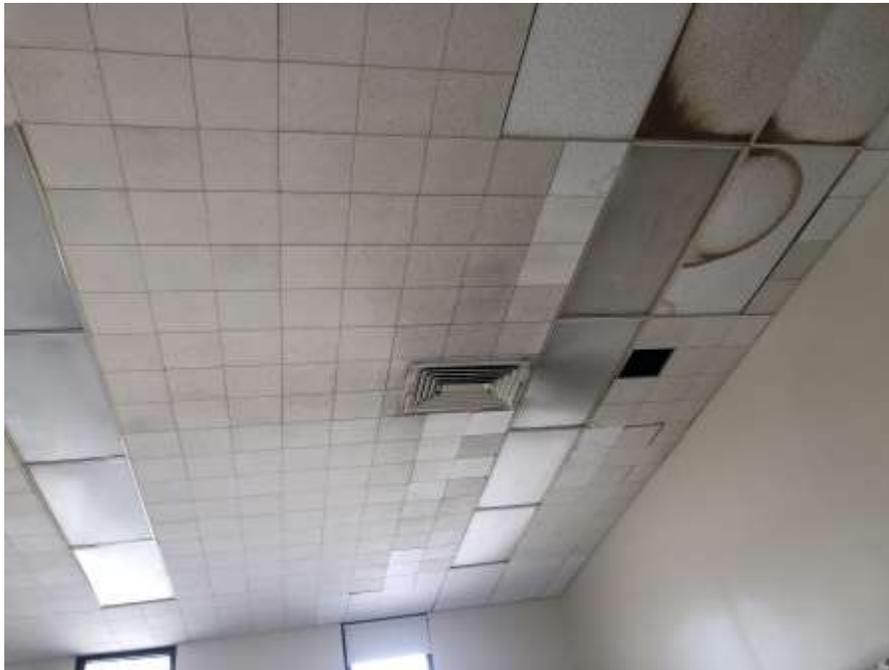
Photograph 10: Ceiling tile in Room E330.

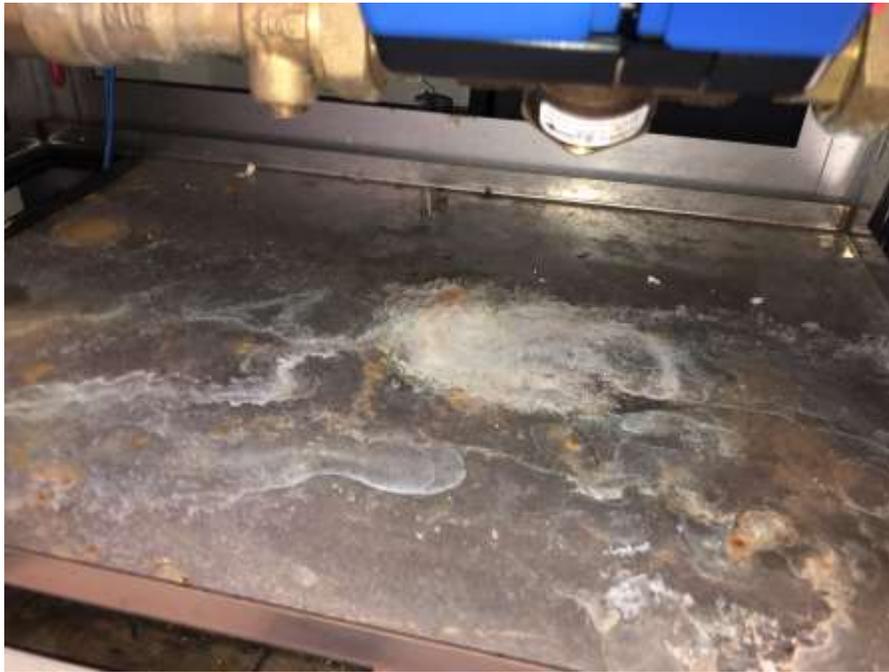
Photograph 11: Previous water building in Classroom Unit Ventilator.

1. Classroom Unit Ventilators (CUVs) throughout the building should be evaluated and serviced to reduce humidity levels to <60%. This evaluation should be completed during cooling season to investigate areas for condensation and excessive humidity.

2. CUV covers and interior components should be cleaned with a biocide. Fiberglass pipe insulation should be removed and replaced.
3. Drywall and plaster behind CUV should be removed in order to prevent microbial growth. Fiberglass pipe insulation, wood framing, any other exposed surfaces should be cleaned and disinfected properly to prevent further mold growth.

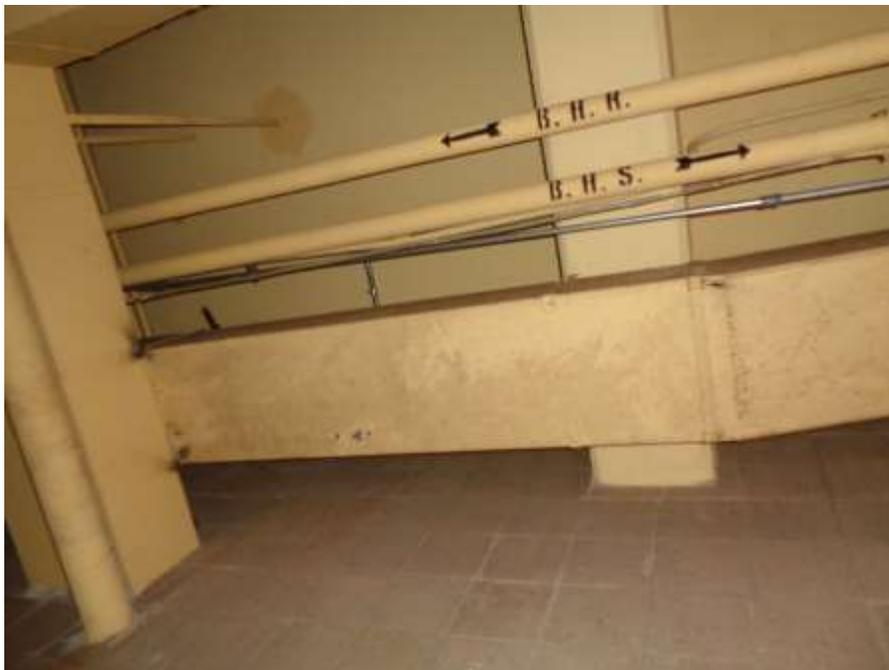
Photograph 12: Metal ducting in Boy's Locker Room.
