**RE: Limited Mold Inspection & Sampling**

Location: Chester Upland School of Arts  
501 W. 9th Street, Chester, PA 19013  
Project #: 20220012

Acer Associates, LLC (ACER) was retained to perform a limited mold inspection and sampling at the above referenced location. The inspection was conducted on January 31, 2022, by Mr. Chuck Wilkins and Mr. Scott Horn, a Certified Microbial Consultant.

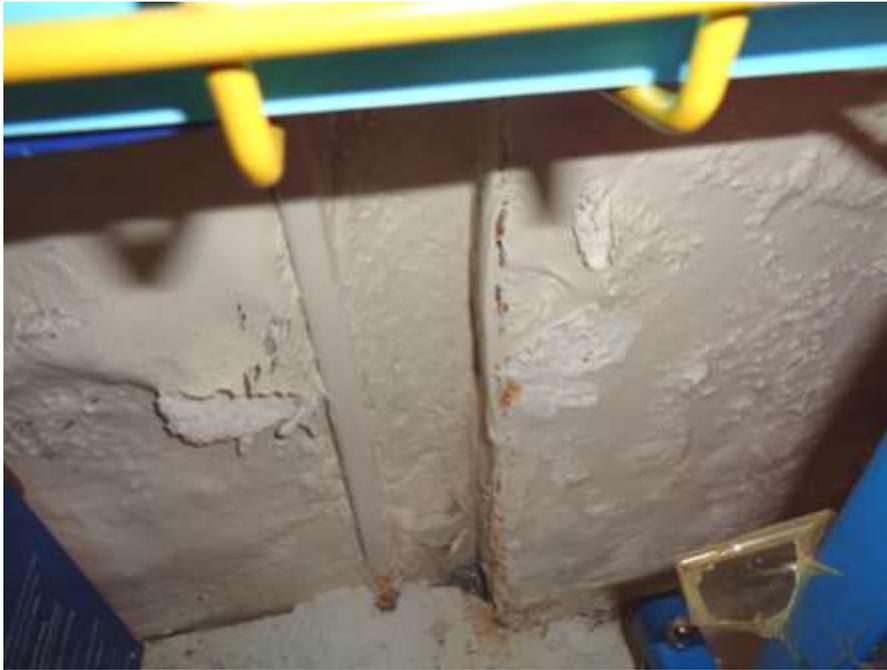
ACER’s inspection and tape lift sampling confirmed mold growth to be present on the drywall walls and floor tiles located in Rooms 009A and 009. The plaster walls that remain in the rooms show significant signs of water damage. According to Brian Pyatt from the Chester Schools Facility Department, the exterior walls of the structure area allowing water into this area and the leak is a persistent problem.

Photograph 1: Significant water intrusion on Plaster walls in Room 009.

1. The building exterior located outside of Rooms 009 and 009A should be evaluated for water intrusion issues and should be corrected accordingly.
2. The floor tile and drywall and plaster walls in Rooms 009A and 009 should be removed. All exposed surfaces should be cleaned and disinfected properly to prevent further mold growth.
3. The wall cavity should be inspected by ACER while opened to further investigate the cause of the of the water intrusion and to verify all mold has been remediated.

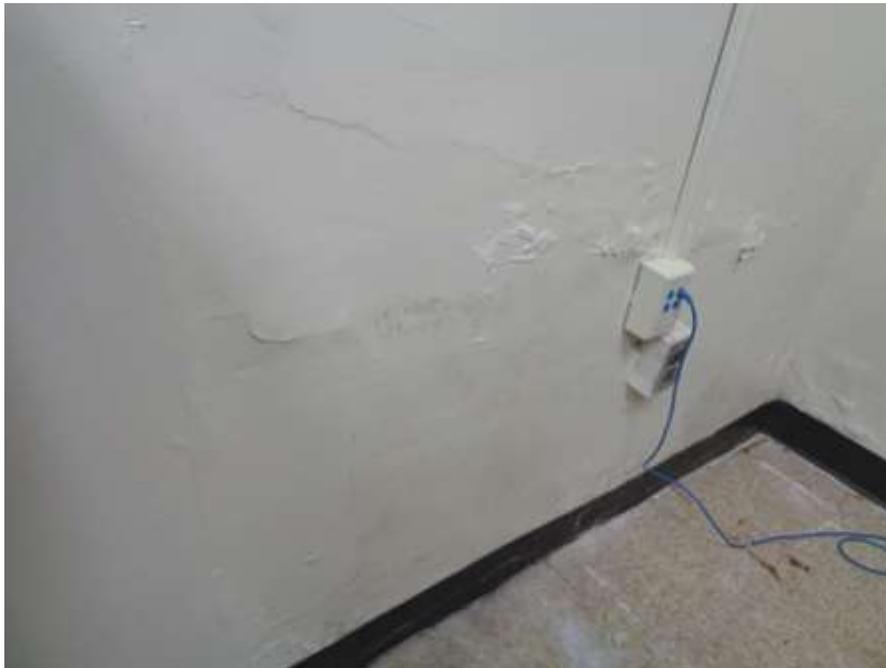
Photograph 2: Drywall walls and 12x12 floor tile located in Room 009A.

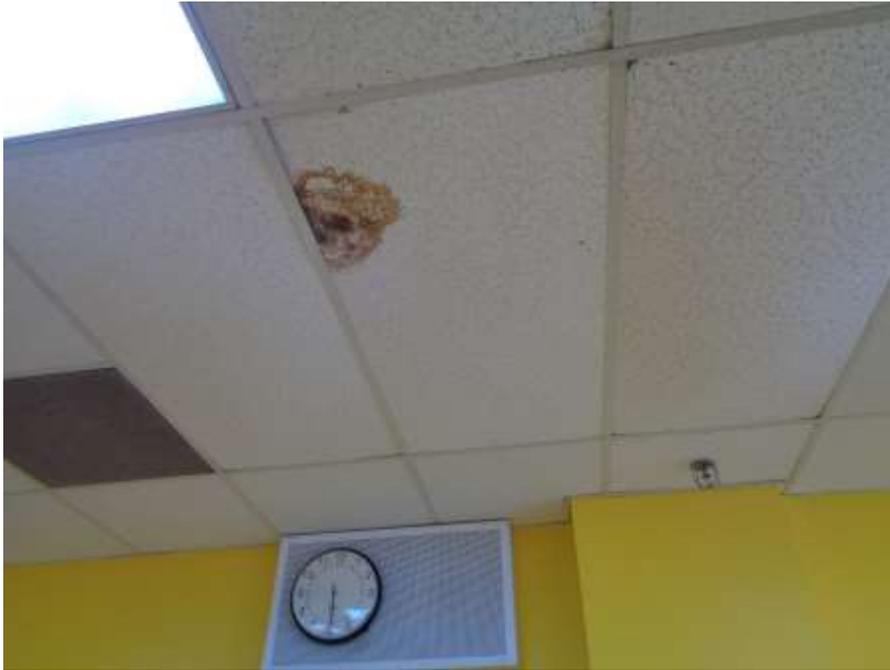
Photograph 3: Ceiling tile in hallways near Main Office.

A potential roof leak was observed in the area above the ceiling tiles near the main office that exhibited mold growth. The roof should be inspected to identify the cause of the water damage. Once the roof is repaired the area located above the ceiling should be cleaned with a biocide and the ceiling tiles be replaced.

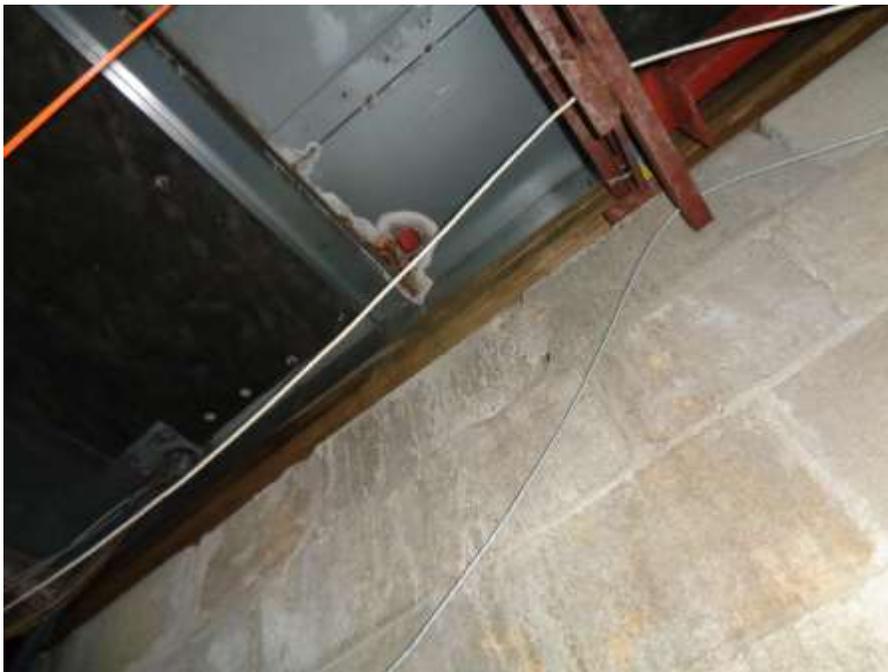
Photograph 4: Potential leaking point above ceiling tiles near main office.

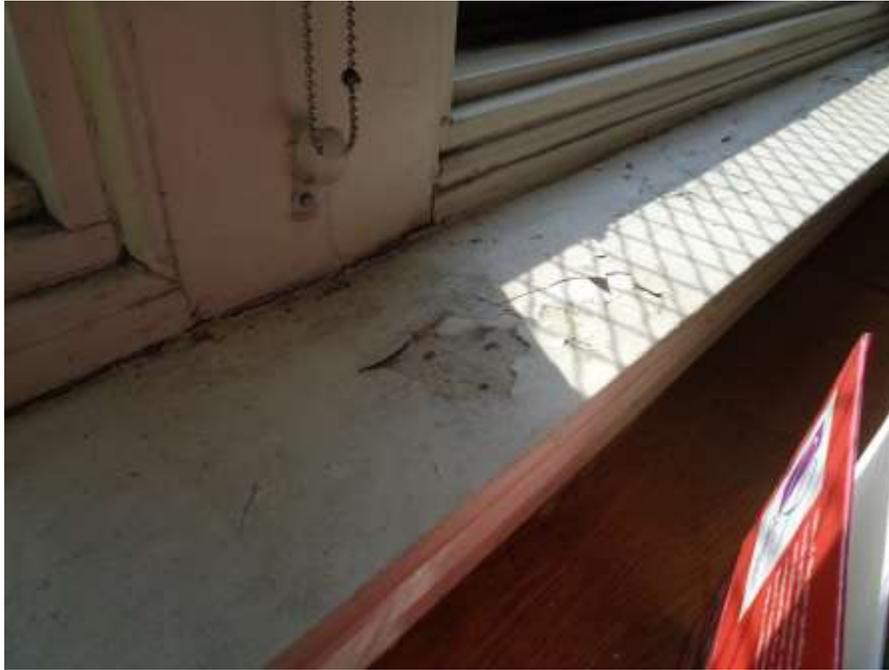
In areas around the windows, mold growth, rot, and water damage was observed on the wood windowsills. The water damaged and rotten windowsills should be removed, and the exposed area inspected for additional mold growth and cleaned with a biocide. New wood windowsills should be installed once an inspection is completed.

Photograph 5: Typical windowsill damage in Room 105.

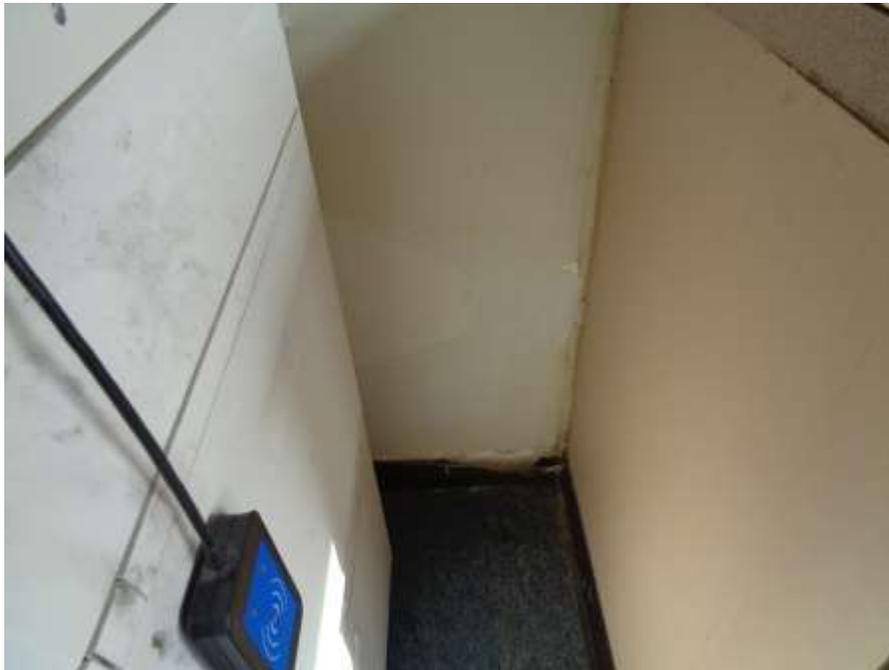
Photograph 6: Drywall located in Room 105.

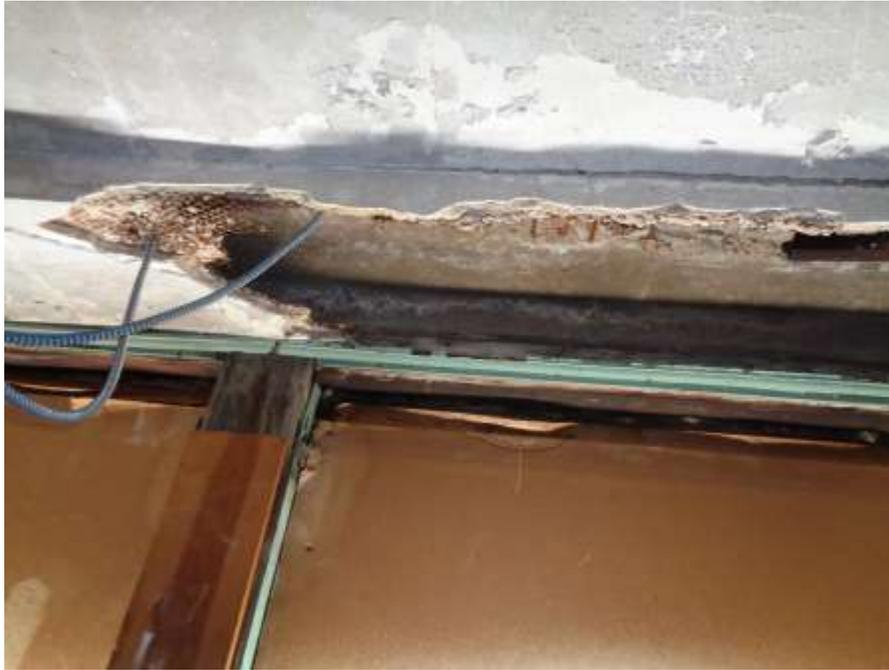
Photograph 7: Damaged plaster and exposed wood window framing in Room 105.

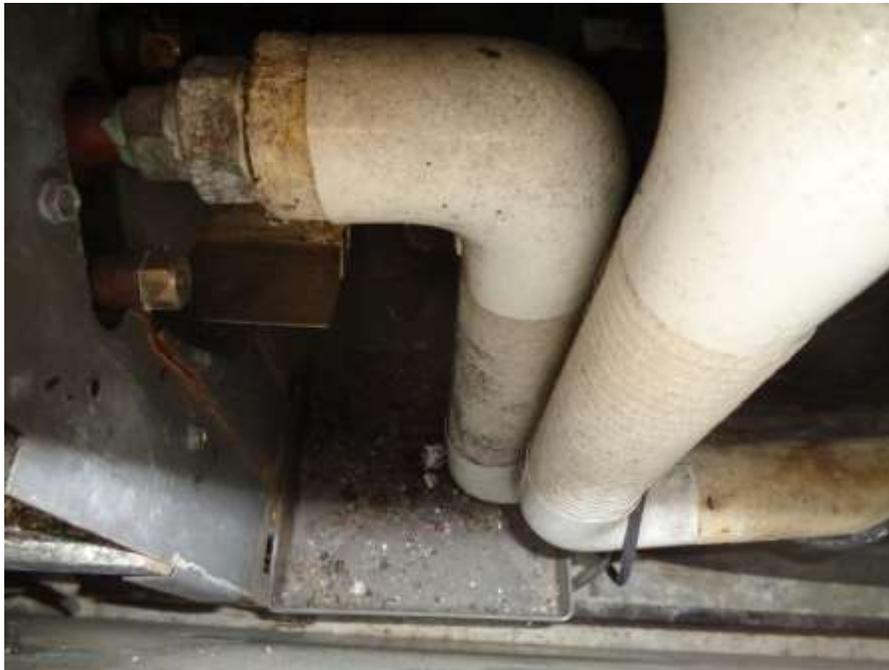
Visible mold growth was observed on fiberglass piping located inside the classroom unit ventilators (CUV). ACER's inspection and tape lift sampling confirmed mold growth to be present on the fiberglass piping located in Room 105, 111, 107, 208, 301, and 307. Additionally, ceiling tiles located in rooms below the unit ventilators (Music Room, and Rooms 105 and 209) showed visible mold growth and water damage. Significant damage to the plaster located above ceiling tiles was observed in the rooms located below these units. Mold growth was observed on the drywall in Room 105. Since ACER observed staining on ceiling tiles which corresponded with the locations of CUVs from floor directly above, ACER recommends the following:

Photograph 8: Fiberglass insulation located inside classroom unit ventilator in Room 105.

1. Classroom Unit Ventilators (CUVs) should be evaluated and serviced to reduce humidity levels to <60%. This evaluation should be completed during cooling season to investigate areas for condensation and excessive humidity.

2. CUV covers and interior components should be cleaned with a biocide. Fiberglass pipe insulation should be removed and replaced.
3. Impacted drywall and plaster behind/adjacent to the CUV should be removed in order to prevent microbial growth. Fiberglass pipe insulation, wood framing, any other exposed surfaces should be cleaned and disinfected properly to prevent further mold growth.

4. The wall cavity should be inspected by ACER while opened to further investigate the cause of the of the water intrusion and to verify all mold has been remediated.

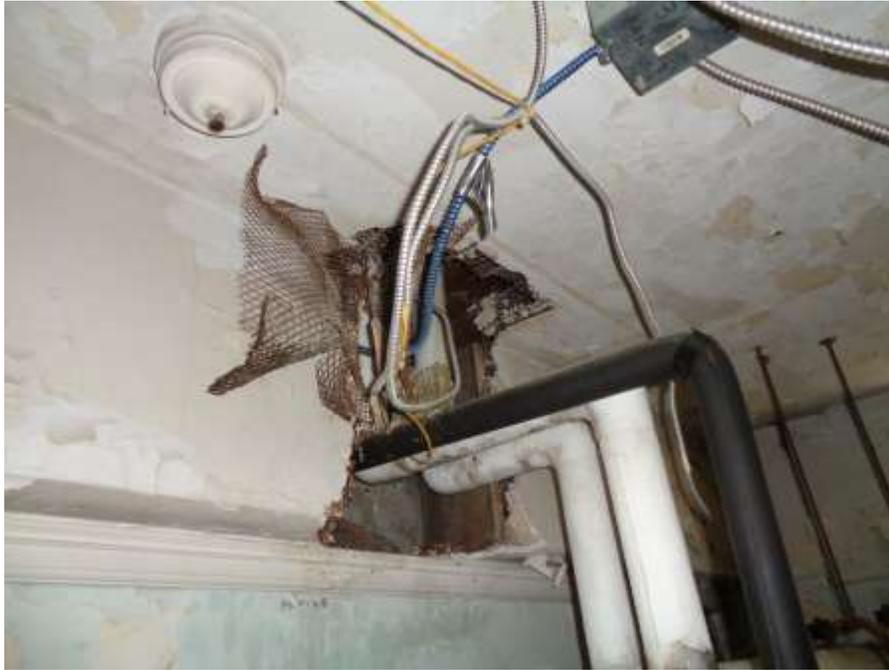
Photograph 9: Damaged plaster, fiberglass pipe insulation and exposed wood window framing in Room 209

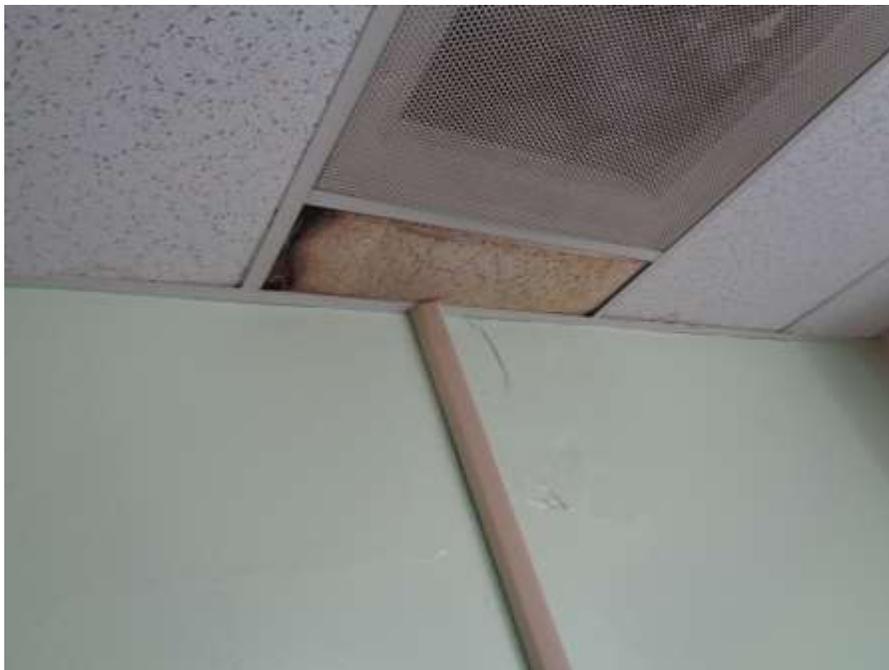
Photograph 10: Ceiling tile in Room 209.

5. The affected ceiling tiles in the areas should be removed and the source of the moisture be determined and repaired prior to replacing ceiling tiles. Due to the potential for the ceiling tiles to contain asbestos, ACER recommends the ceiling tiles be sampled prior to any work.
