**RE: Limited Mold Inspection & Sampling**

Location: Main Street School  
704 Main Street, Brookhaven, PA 19015  
Project #: 20220013

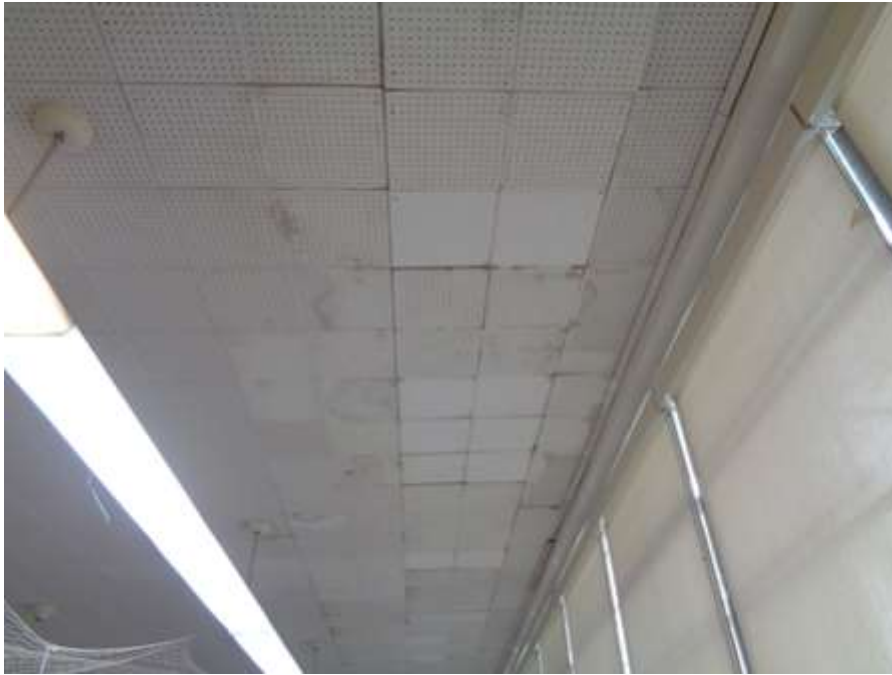
- Staining and damaged/replaced ceiling tiles were observed in the 1<sup>st</sup> floor hallways, Main Office Suite, entryway vestibules, and Rooms 2, 9, 10, 16, 17, 18, 20, and 21.
- Wood window spacers associated with window AC unit in Room 14.
- Wood sink cabinet in Room 9.
- Wood decking and framing above water stained 1'x1' ceiling tiles throughout.

Photograph 1: Ceiling Tiles in Room 10.

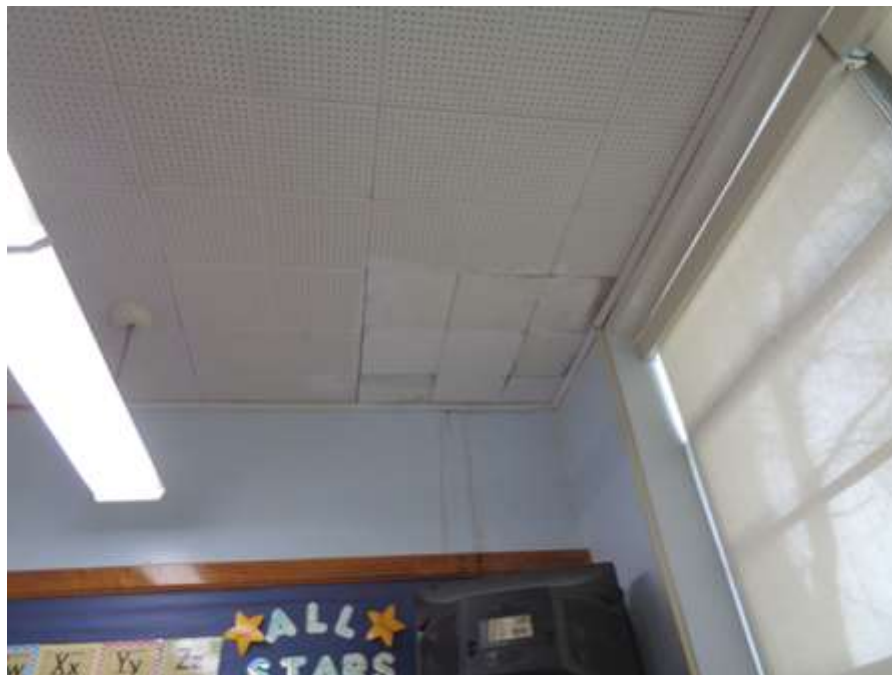
Photograph 2: Ceiling Tiles in Room 17.

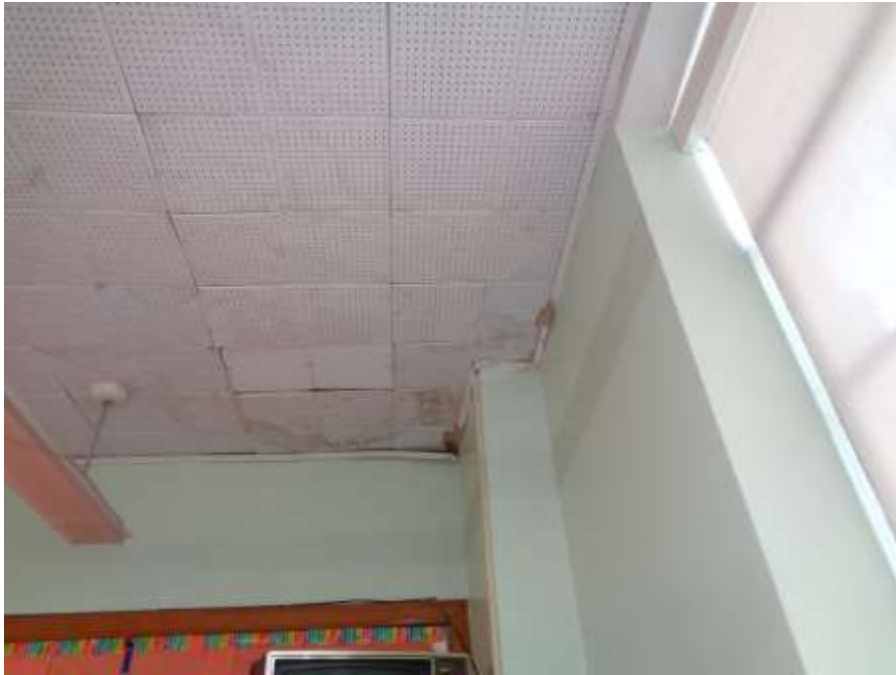
Photograph 3: Ceiling Tiles in Room 9.

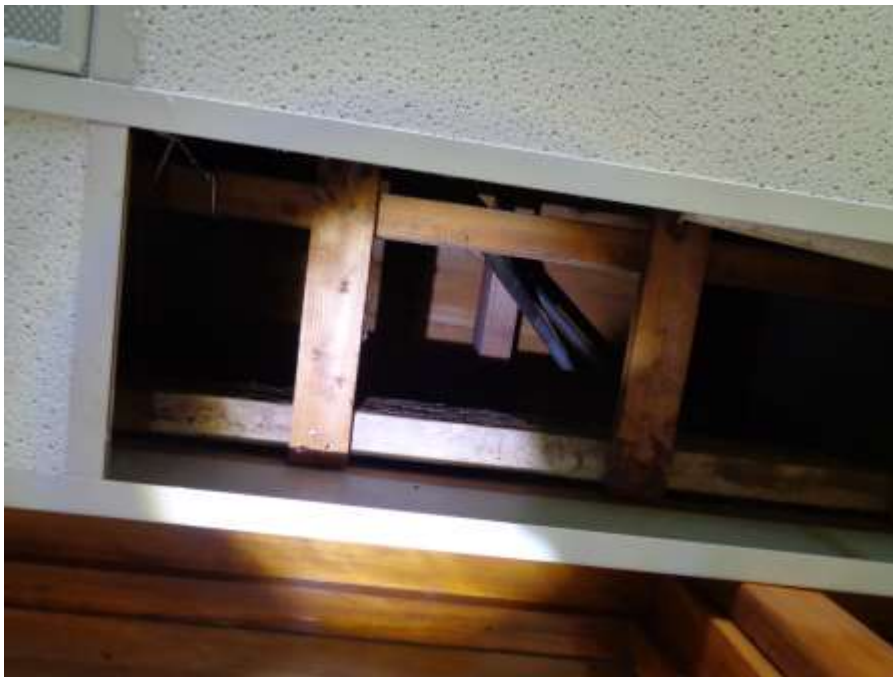
The 1 foot by 1 foot ceiling tiles located throughout the school were suspended with a spline system that could not be fully assessed without damaging the ceiling tiles. ACER was able to confirm visible mold growth was present on the wood joists in areas missing single ceiling tiles. Due to the extent of water damage throughout the school, ACER recommends a limited number of ceiling tiles be removed in rooms where evidence of water leaks exist. This will allow for a complete visual inspection to determine the extent of mold growth on the wood decking and framing above. Due to the potential for the ceiling tiles to contain asbestos, ACER recommends the ceiling tiles be sampled prior to any work. Once the leaks are repaired, the wood joists and framing should be cleaned and disinfected properly to prevent further mold growth.

Photograph 4: Wood framing located above the ceiling.

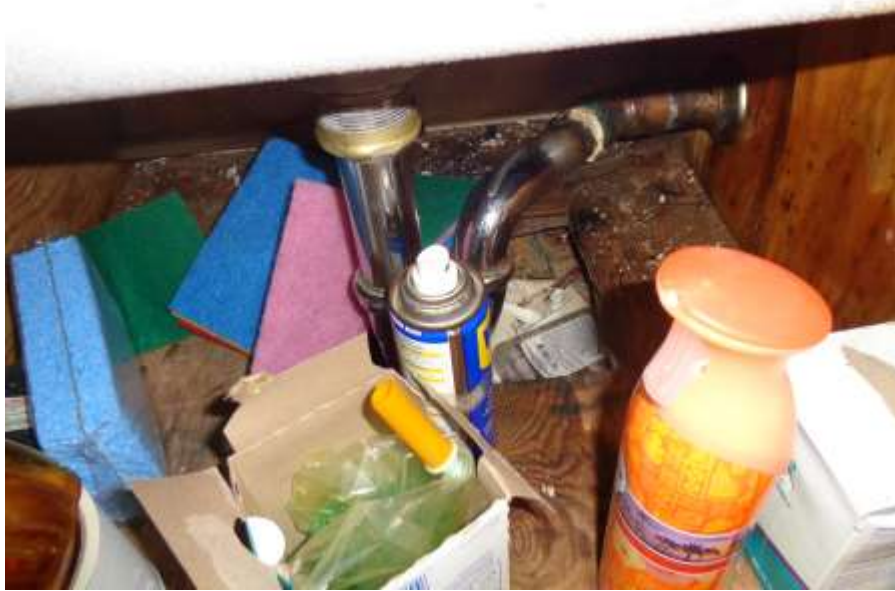
ACER's inspection confirmed mold growth to be present on the wood surfaces beneath the classroom sink in Room 9. Additional sinks were inaccessible and the potential exists for mold growth to be present below these sinks. ACER recommends the sink cabinets be replaced and if the plumbing associated with the sinks is to remain in place, that the valves and drain lines be repaired and checked for leaks prior to completion of installation. The areas under the sink cabinets should be cleaned and disinfected properly to prevent further mold growth.

Photograph 5: Wood shelving below classroom sink in Room 9.

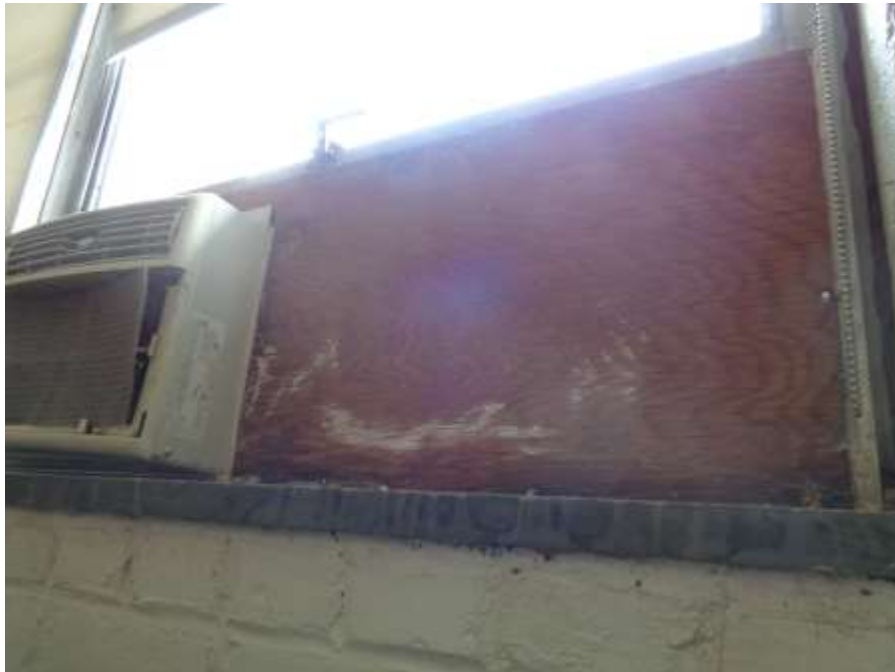
Photograph 6: Wood window spacer with AC unit in Room 14.

The wood window spacer associated with the window AC unit in Room 14 should be removed and replaced. The areas around the spacer should be cleaned and disinfected properly to prevent further mold growth.
