RE: Limited Mold Inspection & Sampling

Location: STEM at Showalter
1100 W. 10th Street, Chester, PA 19013
Project #: 20220014

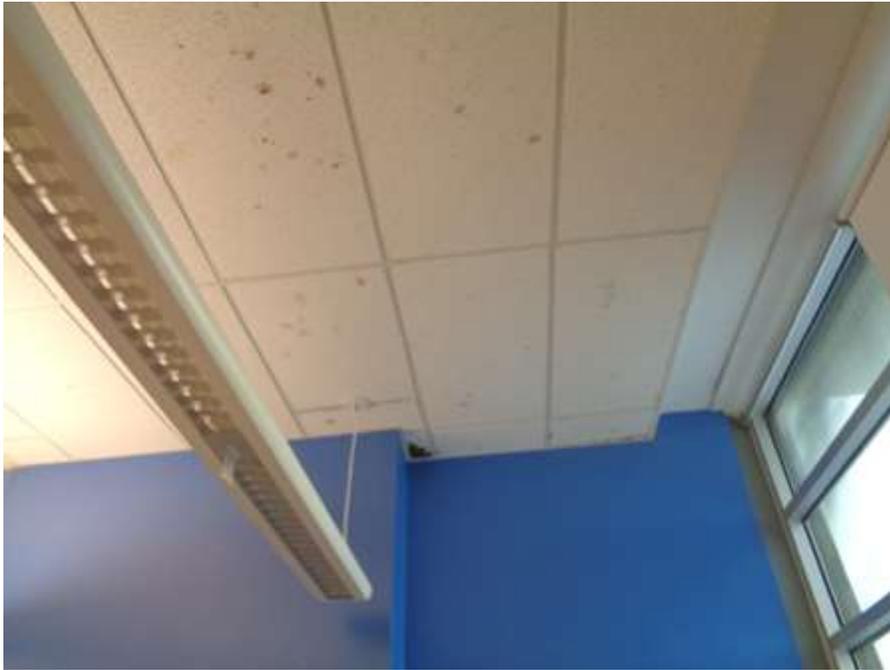
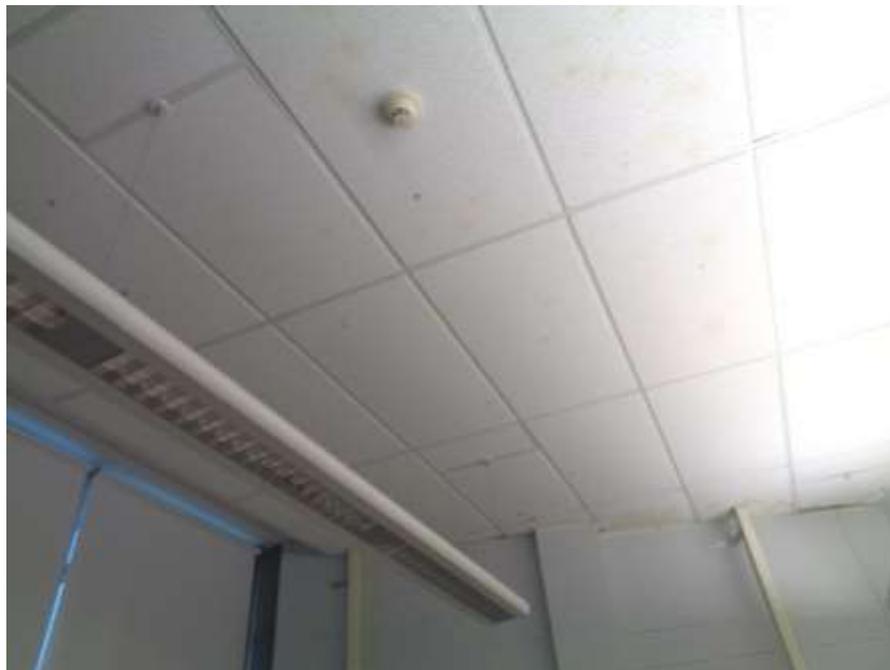
ACER's inspection confirmed staining to be present on the ceiling tiles located in Room 114. According to the teacher in Room 114, squirrels live in the ceiling and the majority of staining was caused by squirrel urine.

Photograph 1: Ceiling tiles in Room 114.

Photograph 2: Ceiling tiles in Room 114.

- I. The affected ceiling tiles in the area should be removed and the source of the moisture be determined and repaired prior to replacing ceiling tiles. If it is determined that squirrels are present above the ceiling tiles, a qualified contractor should be hired to handle the issue. Due to the potential for the ceiling tiles to contain asbestos, ACER recommends the ceiling tiles be sampled prior to any work.

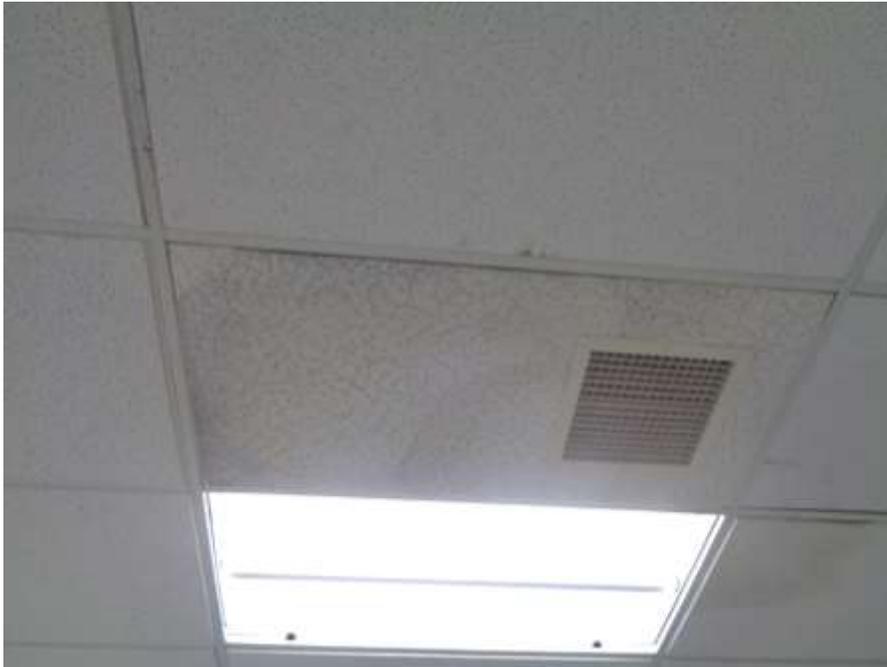
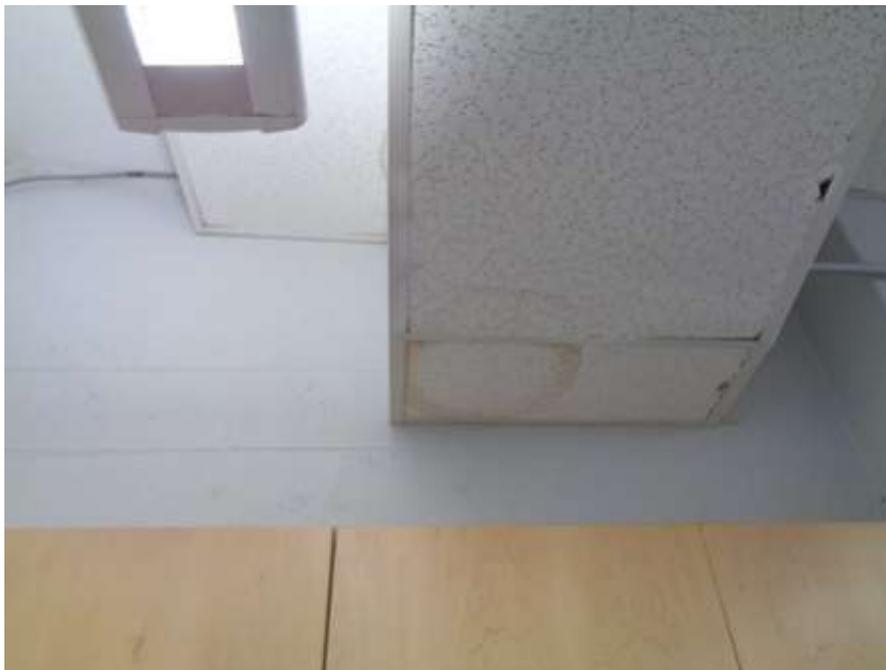
During the inspection, water damage was evident on additional ceiling tiles in classrooms and the hallways throughout. No mold growth was observed during the inspection, however, the potential exists for future mold growth if the water intrusion issue continues in these areas. These areas should be monitored to ensure the water intrusion is no longer active or persistent.

Photograph 3: Examples of stained ceiling tiles observed throughout.

Photograph 4: Examples of stained ceiling tiles observed throughout.

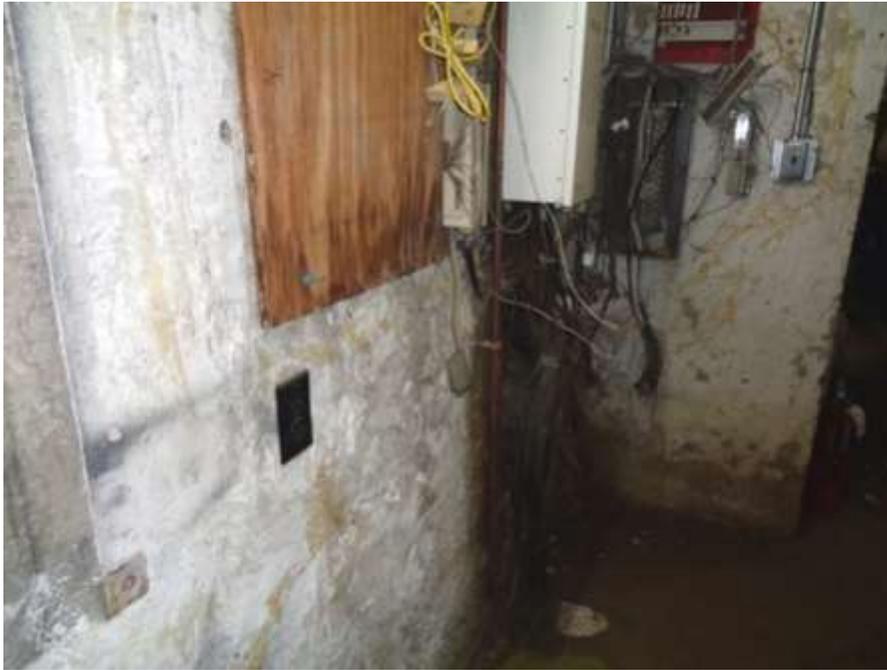
Photograph 5: Wood wall mount with visible mold growth.

ACER's inspection confirmed mold growth to be present on the air handler unit, cardboard boxes, and wooden wall mount located in the boiler room. The cardboard boxes should be emptied and disposed of. The air handler, wooden wall mount and the contents of the cardboard box should be cleaned and disinfected properly to prevent further mold growth.

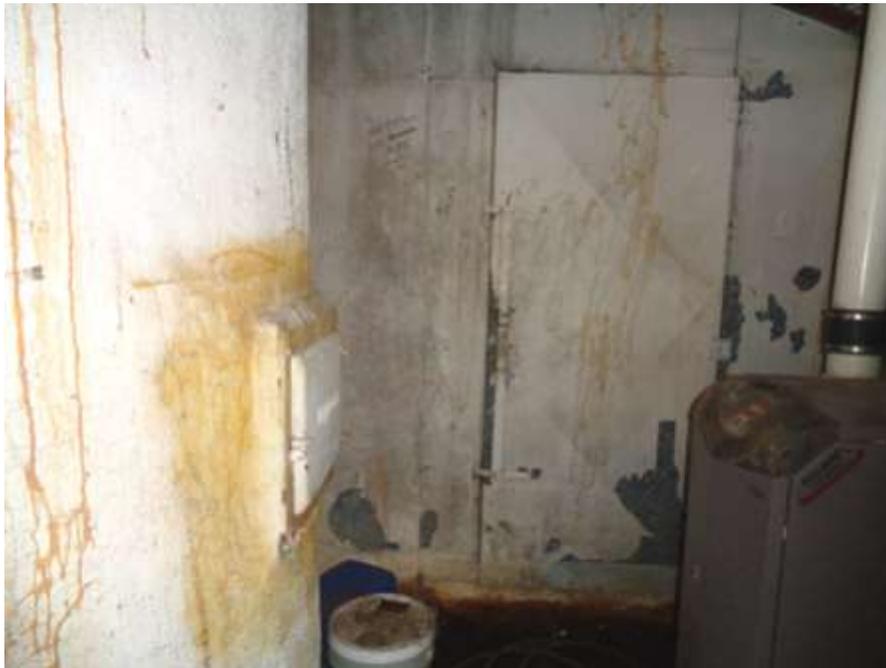
Photograph 6: Air handler unit with visible mold growth.

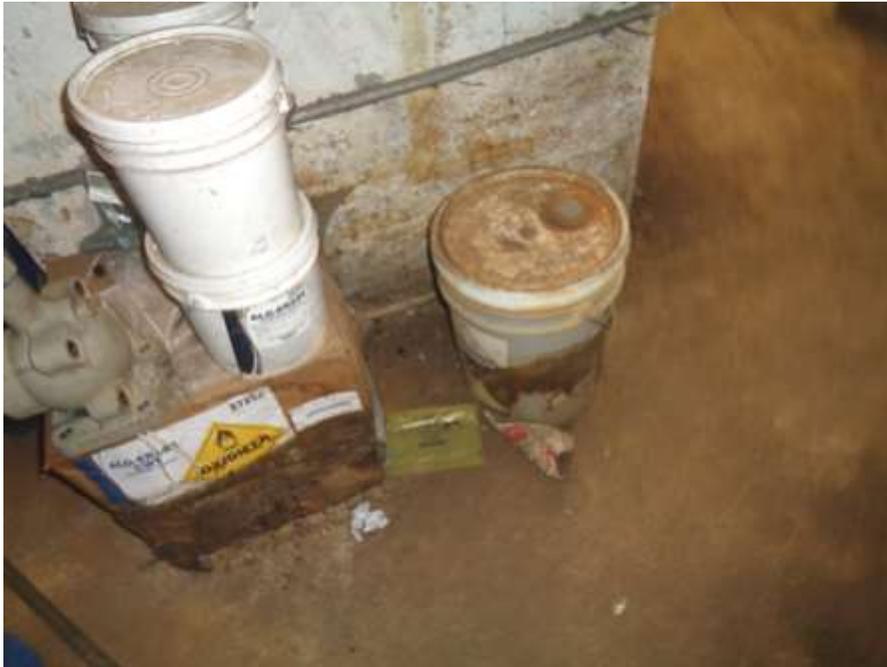
Photograph 7: Carboard box with visible mold growth.
