RE: Limited Mold Inspection & Sampling

Location: Stetser Elementary School
808 E. 17th Street, Chester, PA 19013
Project #: 20220010

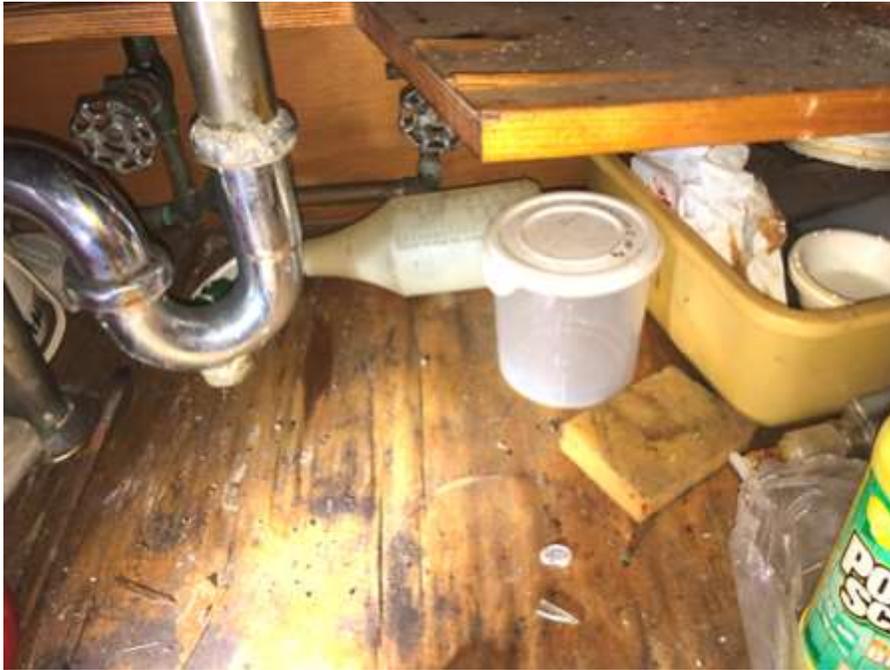
ACER’s inspection and tape lift sampling confirmed mold growth to be present on the wood surfaces beneath the classroom sinks in Rooms 101, 102, 103, 105, 106, 107, 108, 109, 110, 111, 112, 113, and 114. In addition, ACER observed visible mold growth on the shelving located above the classroom sinks and a wooden windowsill located in Room 114. ACER recommends the sink cabinets and associated shelving be replaced and if the plumbing associated with the sinks is to remain in place, that the valves and drain lines be repaired and checked for leaks prior to completion of installation. The areas under the sink cabinets should be cleaned and disinfected properly to prevent further mold growth.

Photograph 1: Wood shelving below classroom sink in Room 101.

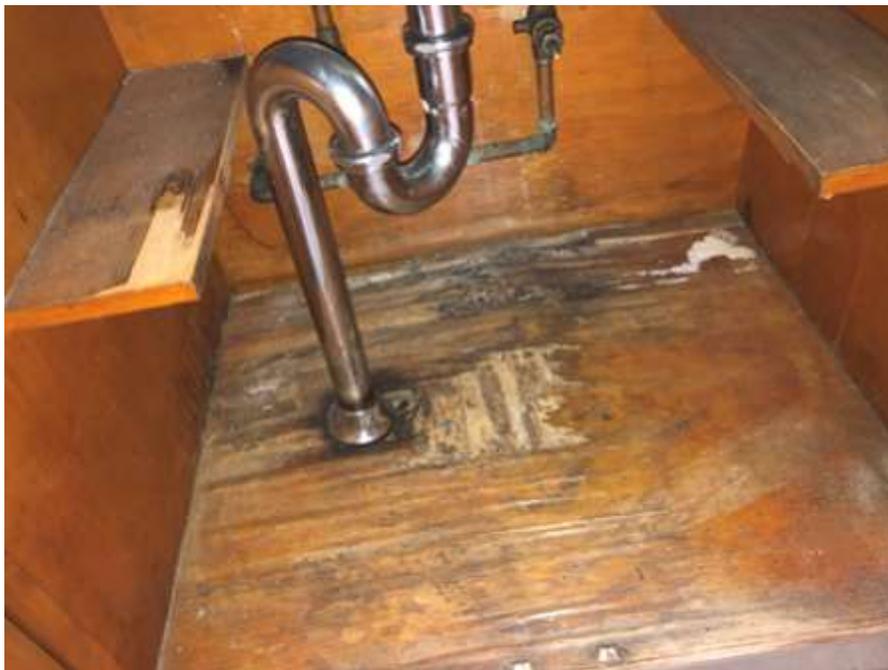
Photograph 2: Wood shelving below classroom sink in Room 114.

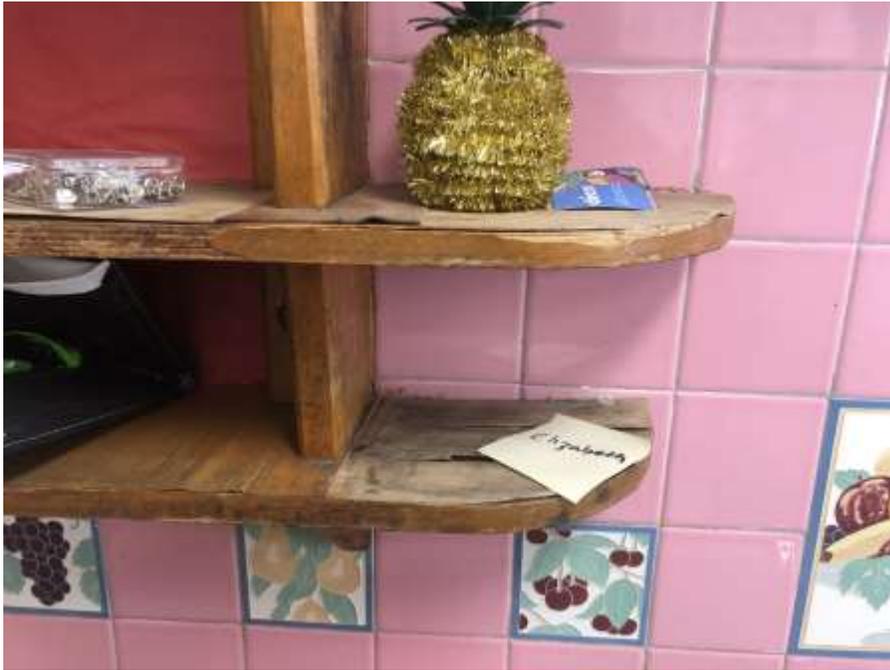
Photograph 3: Wood shelving above classroom sink in Room 103.

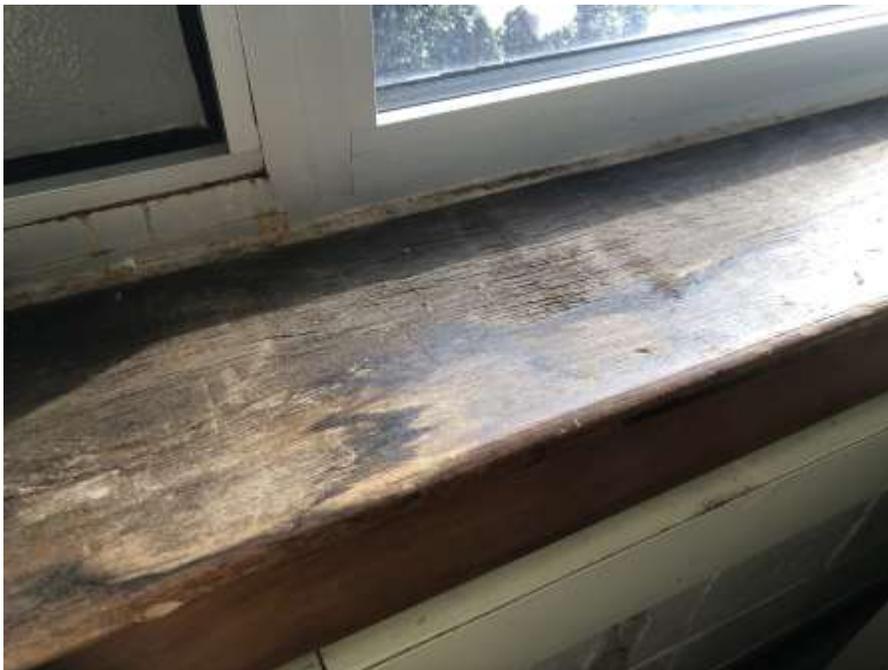
The mold growth observed on the wooden windowsill located in Room 114 was likely related to bad seals on the windows. ACER recommends the window caulking be removed around the sill area and the area be cleaned and disinfected properly to prevent further mold growth. The window should then be resealed and monitored to ensure no further water intrusion is observed. All remediation activities should be conducted by a qualified mold contractor with properly trained personnel using accepted industry standard procedures for mold remediation. ACER recommends post remediation verification inspection and sampling be conducted to ensure the remediation has been satisfactorily completed

Photograph 4: Wooden windowsill in Classroom 114.

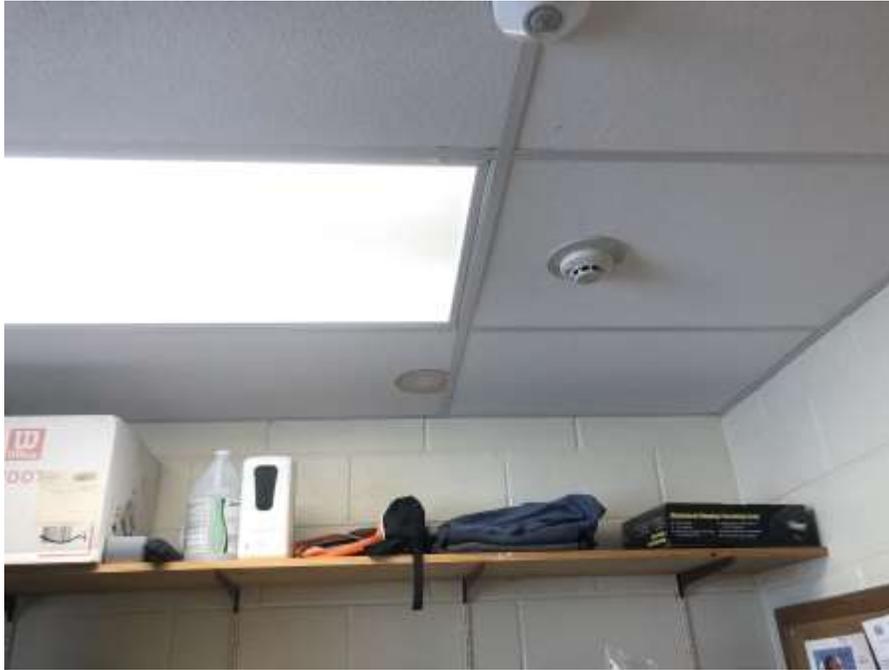
During the inspection, water damage was evident on a ceiling tile in Room 115. No mold growth was observed during the inspection, however, the potential exists for future mold growth if the water intrusion issue continues in these areas. These areas should be monitored to ensure the water intrusion is no longer active or persistent.

Photograph 5: Example of water damage on ceiling tiles in classrooms.

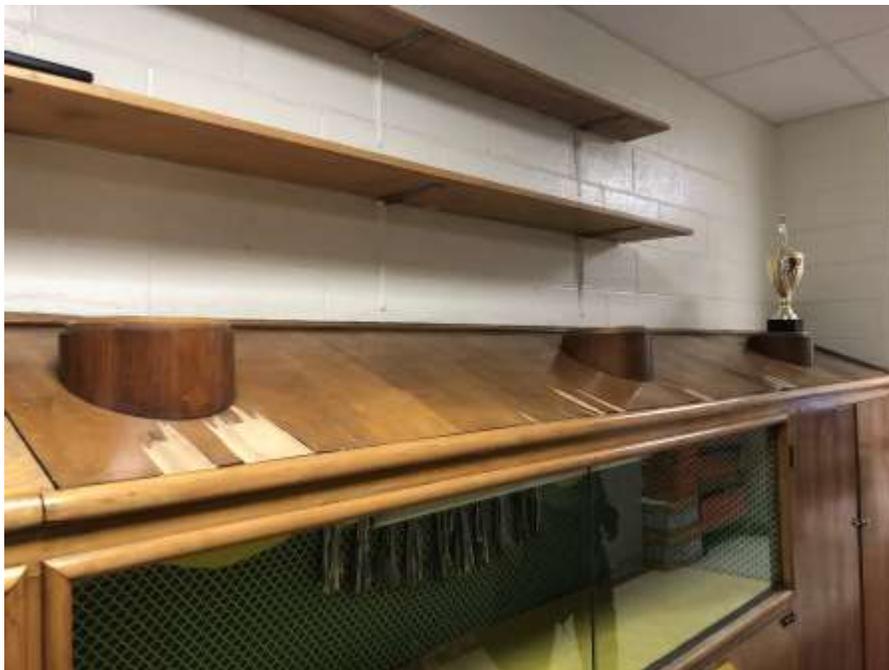
Photograph 6: Evidence of water damage on top of cubbies in the hallways.
