# CHESTER UPLAND SCHOOL DISTRICT FACILITIES STUDY

Prepared by MG Engineering Associates 10/27/2021

# CHESTER UPLAND SCHOOL DISTRICT FACILITIES STUDY 2021

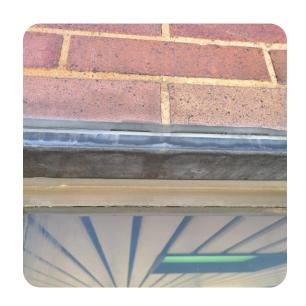
Seals around windows have failed.

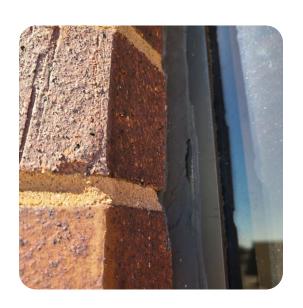
Stone copings are spalling. Window sealants are failing. Boards with nails need to be store properly on the roof to not puncture the roof membrane.

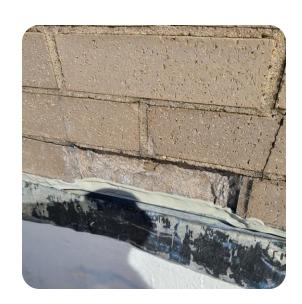
Masonry around perimeter of the roof is failing.

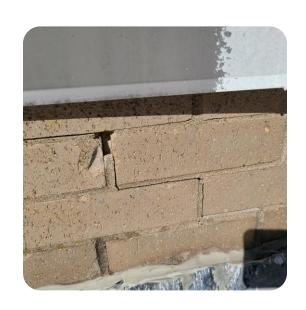
Masonry is failing and open to water entry.

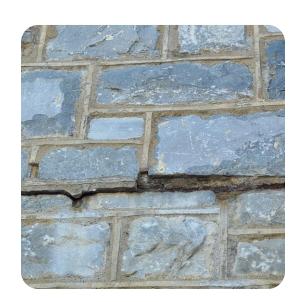
Failing masonry.

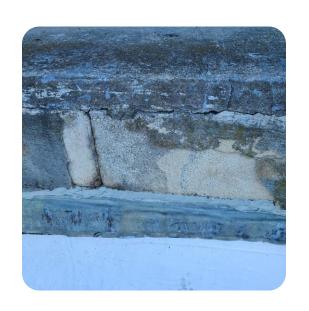
Failing masonry.

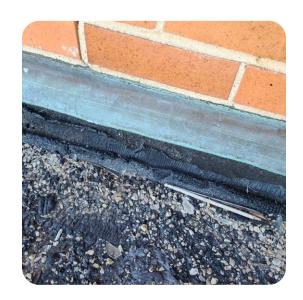
Flashings on BUR roof have failed.

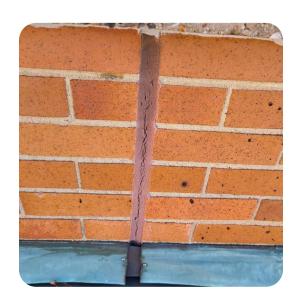
Rebar in exposed concrete is rusting casing the concrete to spall. Building sealants are failing.

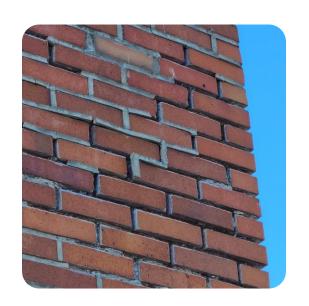
Chimney masonry is failing.

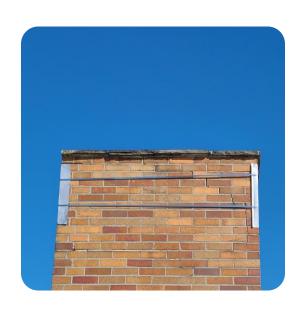
Damaged hood vents should be replaced. Chimney masonry is failing. Debris should be removed from the roof.

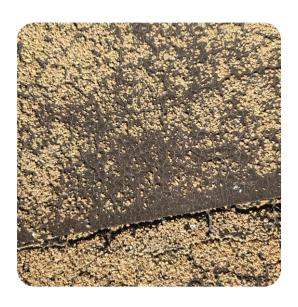
Most of granules have worn off the cap sheet, causing the asphalt to oxidize. Scrim is exposed in deteriorated cap sheet.

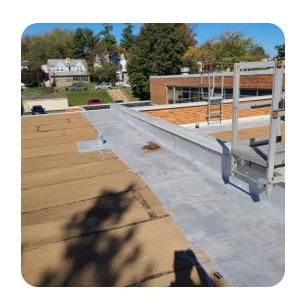
Previous repairs to seams and flashings. Low flashing heights will have to be raised if the roof is replaced.

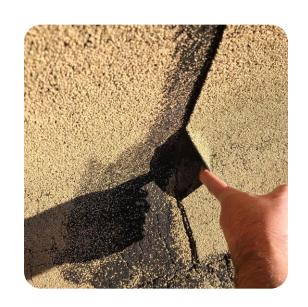
Open seams. Improper flashing detail.

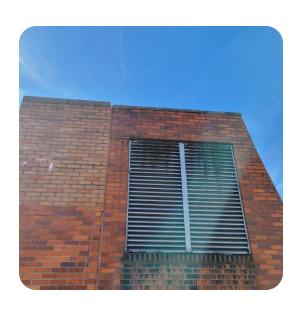
Blisters in cap sheet. Chimney masonry and sealants are failing.

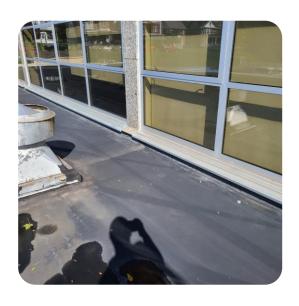
Membrane has deteriorated down to scrim. Punctures in roof.
