# CHESTER UPLAND SCHOOL DISTRICT FACILITIES STUDY

Prepared by MG Engineering Associates 10/27/2021

# CHESTER UPLAND SCHOOL DISTRICT FACILITIES STUDY 2021

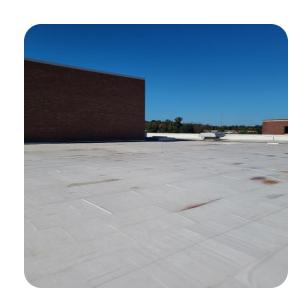
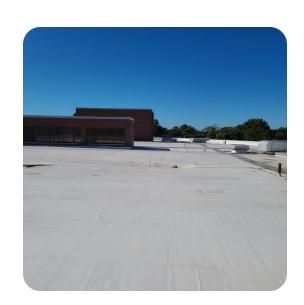
### TPO Roof Areas 14-17

Overview. Roofs were replaced in 2020.

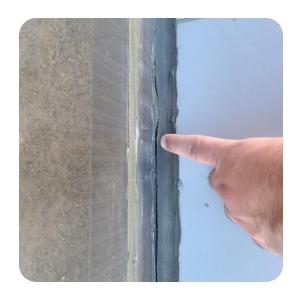
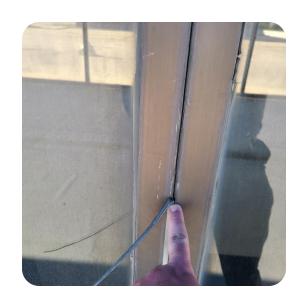
Seals around windows have failed.

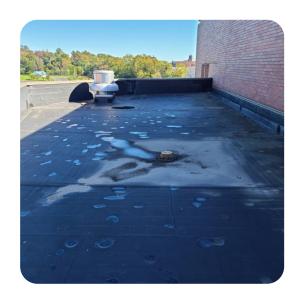
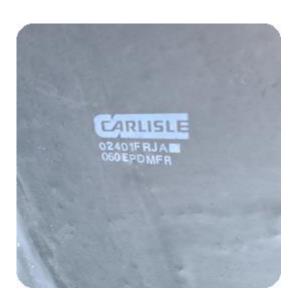
## EPDM Roof Areas 11,12 & 13

Overview. Roofs appear to have been installed in 2001.

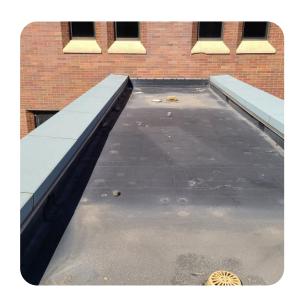
Open seams. Counterflashing sealants are failing.

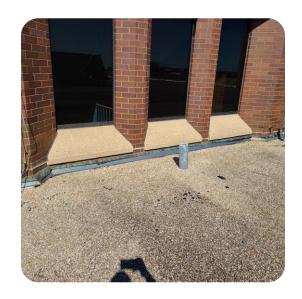
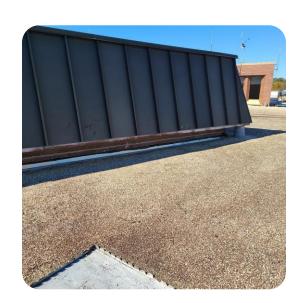
Flashing heights will have to be raised if the roof is replaced.

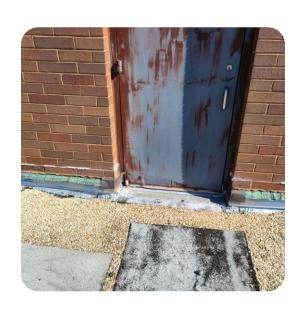
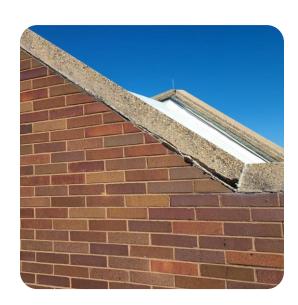
Stone copings are spalling. Window sealants are failing. Boards with nails need to be store properly on the roof to not puncture the roof membrane.

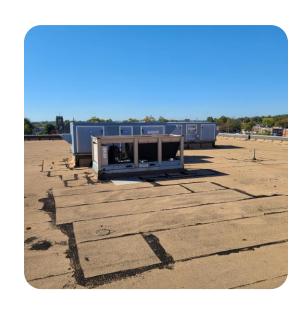
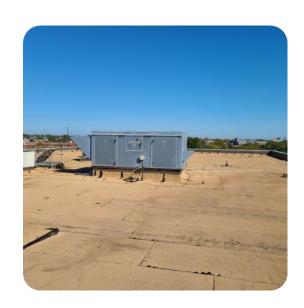
## Roof 1

Overview. Low flashing heights will have to be raised if the roof is replaced.

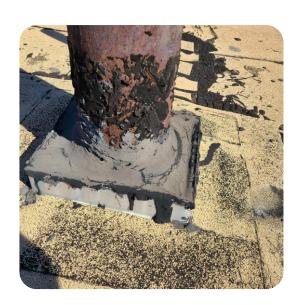
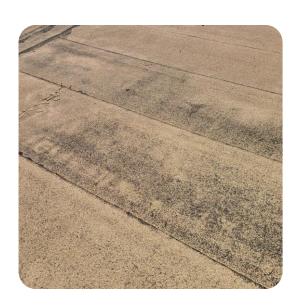
Alligatoring membrane. Scrim is exposed . Open pitch pockets. Granule loss.

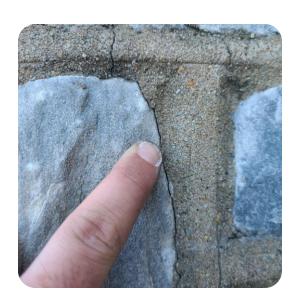
Masonry around perimeter of the roof is failing.

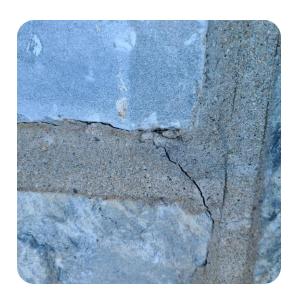
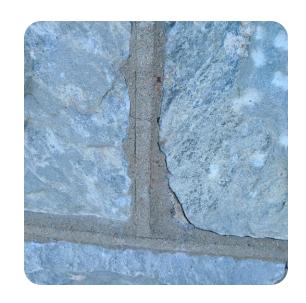
Failing masonry.

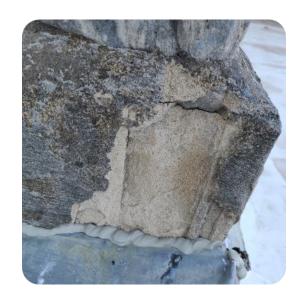
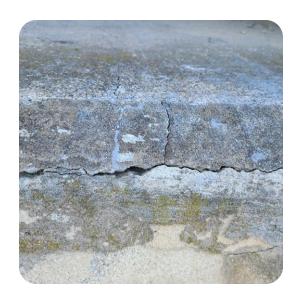
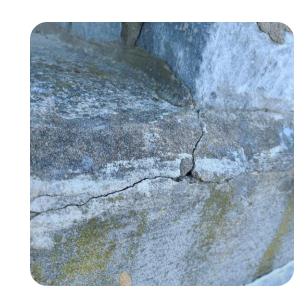
Failing masonry.

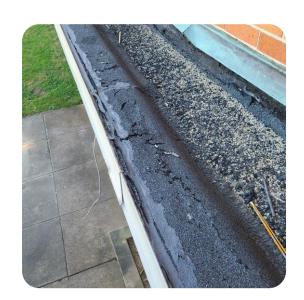
Flashings on BUR roof have failed.

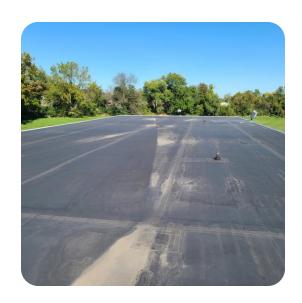
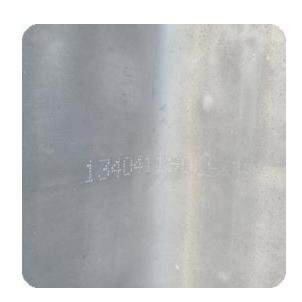
#### **EPDM** Roofs

Overview. EPDM roofs appear to have been installed in 2011.

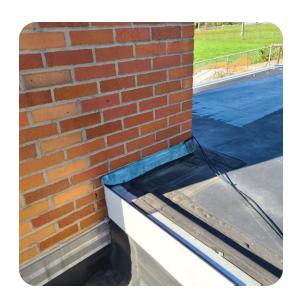
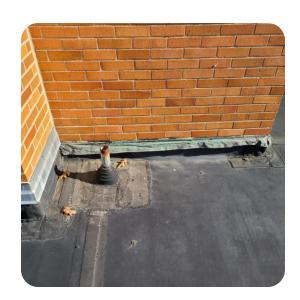
Low flashings will have to be raised if the roof is replaced.

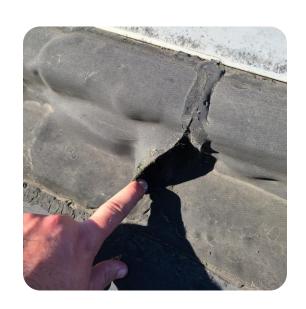
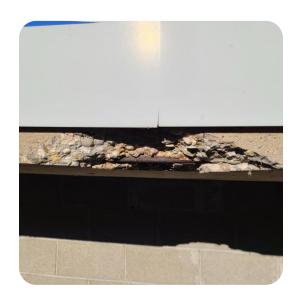
Rebar in exposed concrete is rusting casing the concrete to spall. Building sealants are failing.

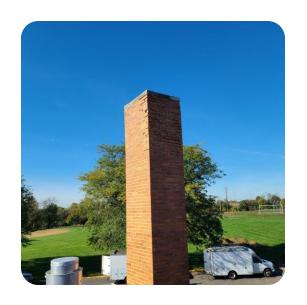
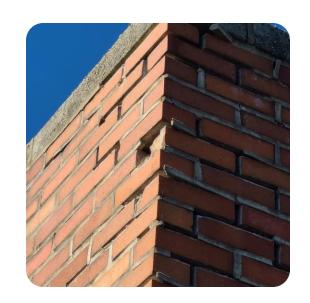
Chimney masonry is failing.

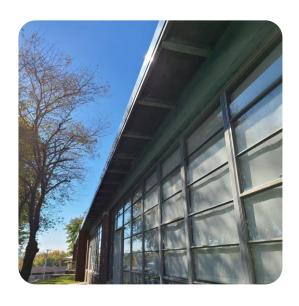
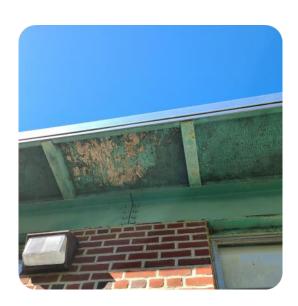
Wooden soffits are starting to rot. Exposed steal beam is rusting.

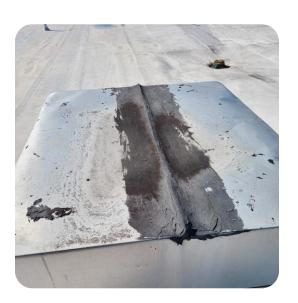
Damaged hood vents should be replaced. Chimney masonry is failing. Debris should be removed from the roof.

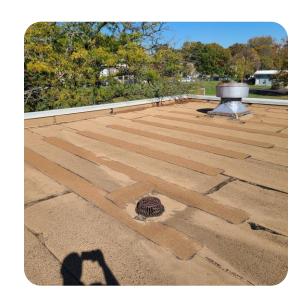
Most of granules have worn off the cap sheet, causing the asphalt to oxidize. Scrim is exposed in deteriorated cap sheet.

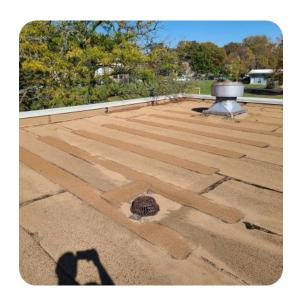
Previous repairs to seams and flashings. Low flashing heights will have to be raised if the roof is replaced.

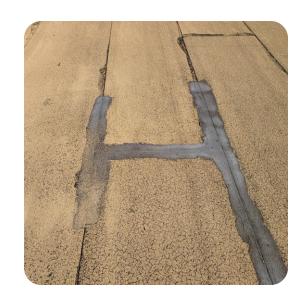
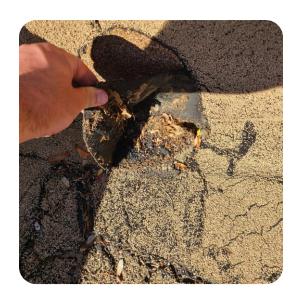
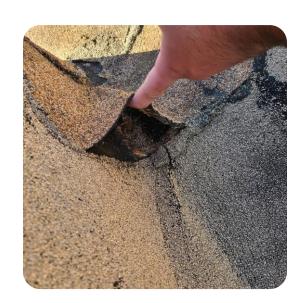
Open seams. Improper flashing detail.

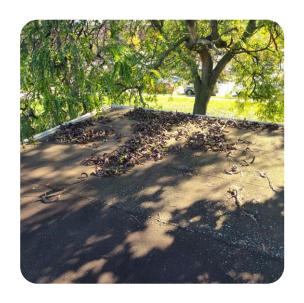
Plants are growing in debris on the roof. Debris is clogging roof drains.

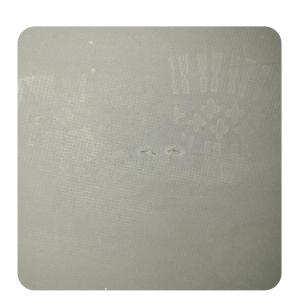
Membrane has deteriorated down to scrim. Punctures in roof.
